Audit Report Number	2007-KC-1002
---------------------	--------------

SUBJECT: Manufactured Home Lending by Wells Fargo Home Mortgage,  
West Des Moines, Iowa

### Finding 1: Wells Fargo Underwrote One Title II Manufactured Housing Loan for a Property with an Ineligible Foundation

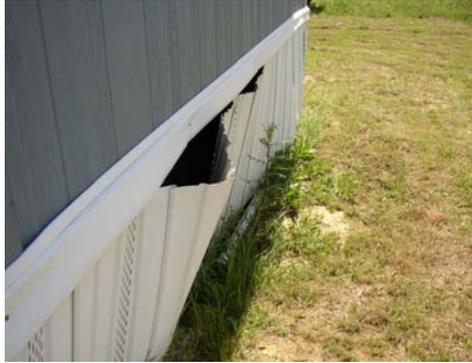
HUD requires Title II manufactured homes to have skirting that is permanent or attached to a permanent foundation. The property did not have skirting that met HUD requirements. The following inspection photograph shows that the skirting was not permanent or attached to a permanent foundation.

Skirting was not permanent or attached to a permanent foundation. Skirting was thin vinyl siding with several bulges, tears, and holes throughout. Skirting was missing in several places. Several holes underneath skirting that showed no footing.

Skirting was not permanent or attached to a permanent foundation. Skirting was thin vinyl siding with several bulges, tears, and holes throughout. Skirting was missing in several places. Several holes beneath skirting showed no footing.

At the time the appraisal was completed on October 8, 2004, the appraiser required that skirting be repaired or replaced on the left and right side of the unit. Inspection Report shows that the skirting damage was repaired. It is likely the additional damage showing on the disc photo occurred over a period of time, after the loan closed and prior to the time the disc photos were taken.

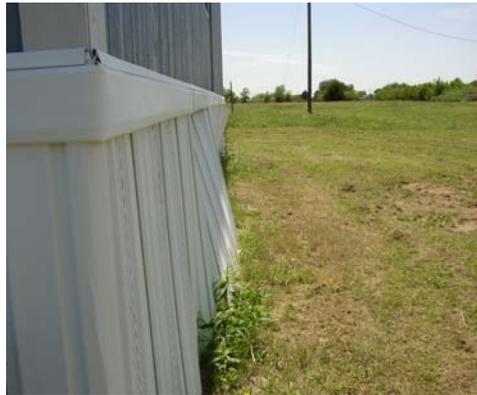
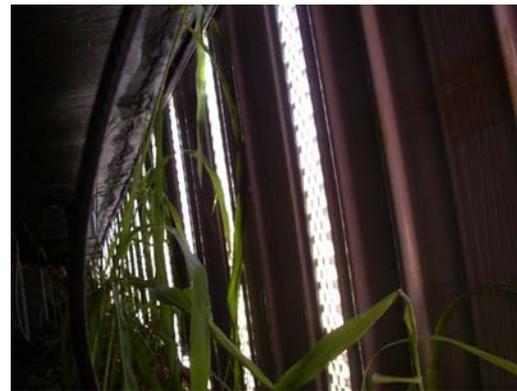
HUD requires Title II manufactured homes to have a permanent perimeter wall to exclude entry of water and vermin. The property did not have an adequate permanent perimeter wall. The wall was thin vinyl siding with holes throughout that would allow entry of water and vermin. There were no reinforcement rods permanently attaching the perimeter wall. The following inspection photographs show the failed perimeter wall.

No permanent perimeter wall. The perimeter wall was made of thin vinyl siding. No reinforcement rods were evident. The vinyl was sitting on top of the finished grade and had several gaps and holes throughout that would allow water and vermin entry into the crawl space. No foot under perimeter wall was evident.

There was no permanent perimeter wall. The perimeter wall was made of thin vinyl siding. No reinforcement rods were evident. The vinyl was sitting on top of the finished grade and had several gaps and holes throughout that would allow water and vermin entry into the crawl space. No footing under perimeter wall was evident.

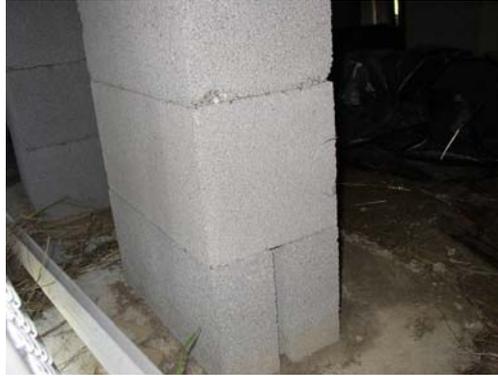
HUD requires Title II manufactured homes to have piers that have mortared bed and head joints (i.e., dry-stacked piers are not permitted). The property piers did not have mortared bed and head joints. The following inspection photograph shows that the piers were dry stacked.

Piers were constructed of concrete blocks that were dry stacked (not mortared) and installed under the chassis beams. Some piers were sitting on poured concrete footings and some were sitting on top of the finished grade with no visible footing. Wood shims were used to level piers under chassis.

Piers were constructed of concrete blocks that were dry stacked (not mortared) and installed under the chassis beams. Some piers were sitting on poured concrete footings, and some were sitting on top of the finished grade with no visible footing. Wood shims were used to level piers under chassis.

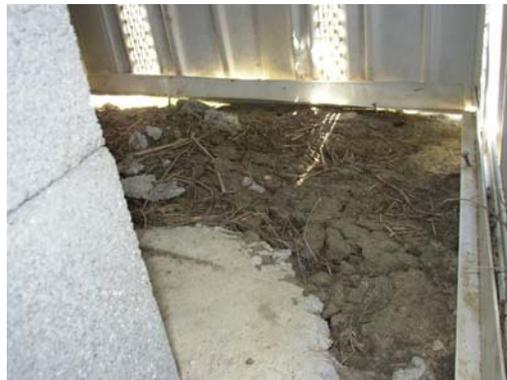
HUD requires Title II manufactured homes to have reinforced concrete footings under the piers and perimeter wall. The property did not have reinforced concrete footings under the perimeter wall, as the following photograph shows.

No footing under perimeter wall. Wall was thin vinyl skirting sitting on top of finished grade. Some piers were sitting on poured concrete footings but we could not determine the depth. Some piers were sitting on finished grade with no visible footing.

There was no footing under the perimeter wall. The wall was thin vinyl skirting sitting on top of finished grade. Some piers were sitting on poured concrete footings, but we could not determine the depth.
