**PHASE I ENVIRONMENTAL SITE ASSESSMENT
LAS ALTURAS
3525 WHITTIER BOULEVARD
LOS ANGELES, CALIFORNIA 90023
(APNs 5188-005-019, -020, and -021)**

Retirement Housing Foundation

SCS ENGINEERS
3900 Kilroy Airport Way, Suite 100
Long Beach, California 90806
(562) 426-9544

June 13, 2011
File No. 01208097.09

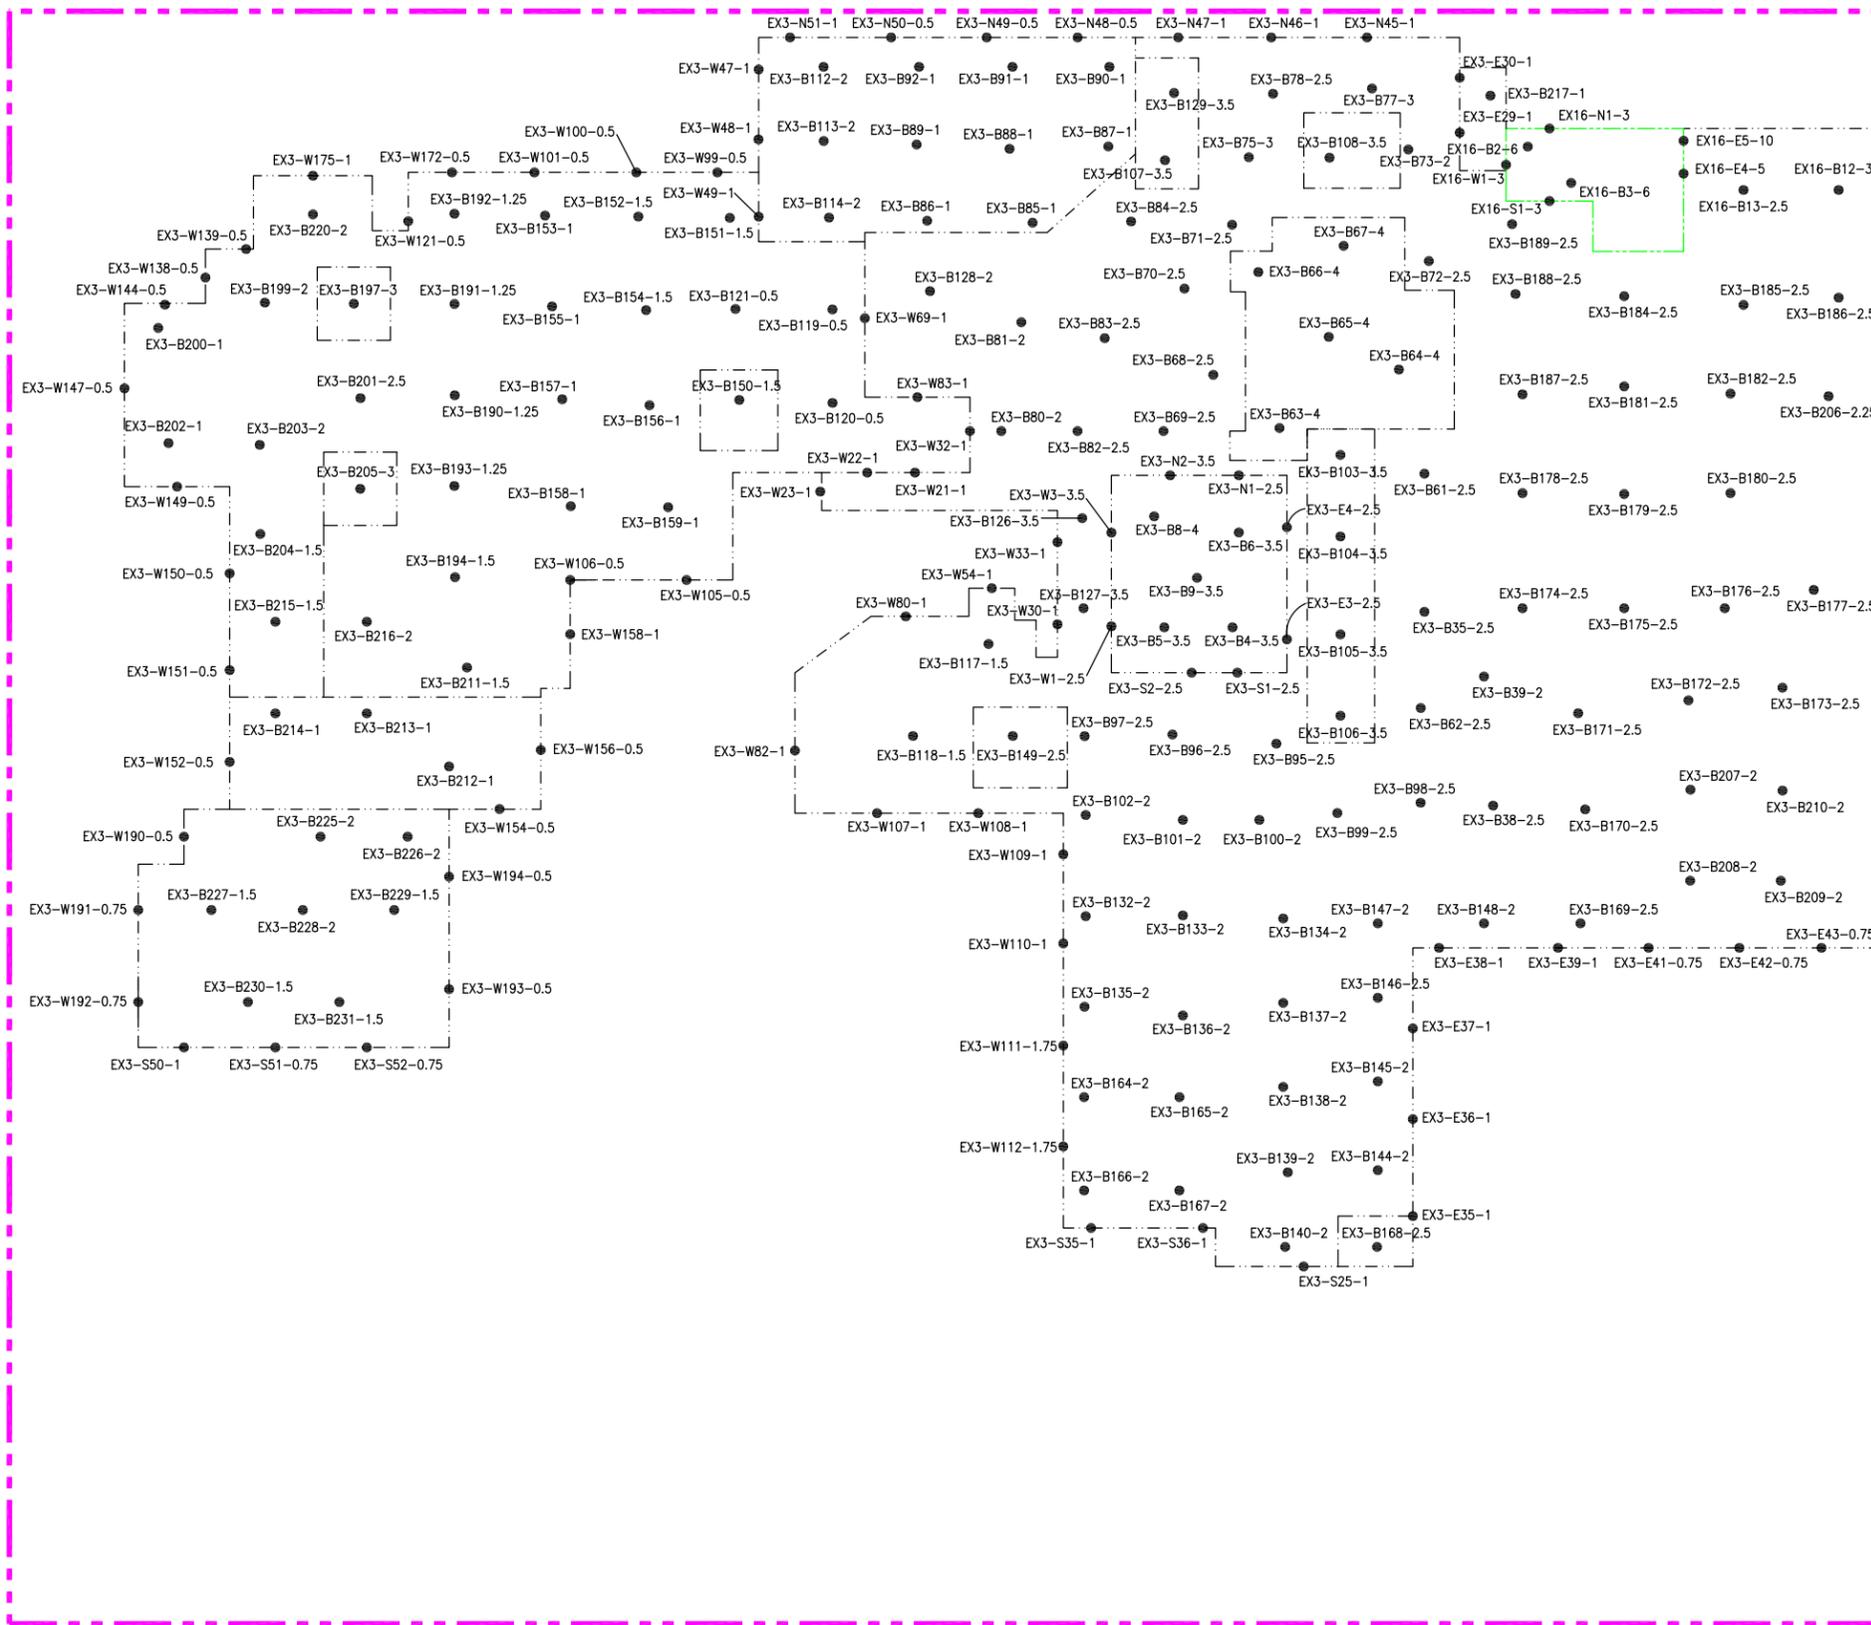
SCS conducted remedial excavation activities at the Las Alturas Property to remove soils impacted with lead. During initial excavation activities in the areas of previous borings SB3 and SB16, a layer of soil and debris ranging in thickness from a few inches to approximately two feet was encountered which extended laterally across a majority of the Property. The debris-containing soil within this layer were found to contain elevated concentrations of lead and was therefore removed. The debris layer ranged in thickness from a few inches to approximately two feet. An X-Ray Fluorescence (XRF) analyzer was used onsite during the excavations to screen soils and guide the excavation. When field screening indicated acceptable concentrations, a confirmation sample was collected for laboratory analysis. With few exceptions, the excavation was extended until confirmation soil samples were collected with lead concentrations below the cleanup goal of $80 \text{ mg}/\text{kg}$ or until excavation could no longer be contained without undermining

Another debris layer was observed at a depth ranging from approximately 5 to 10 feet in the north and east sidewall of Ex16 located near the northeast corner of the Property. Due to the depth of the occurrence of this debris layer, shoring would be required to remove debris at Ex16. A subsurface soil investigation was conducted to further define concentrations of lead that remains in place. During boring activities, thin layers of debris were observed in 3 of the 6 borings, however all lead concentrations in the 28 soil samples analyzed from the 6 borings contained lead below the limit of 400 mg/kg that was established as an acceptable level for deep soil by the SMU.

As a part of remediation activities, a total of approximately 1,771 tons (1,513 tons of non-RCRA California hazardous and 258 tons of non-hazardous) of soil with lead concentrations above the cleanup goal of 80 mg/kg were excavated, loaded into trucks, and transported under manifest to a facility for disposal.

ELEVATION OFF-SITE IS LOWER THAN ON-SITE, THEREFORE THERE IS NO SOUTHEAST SIDEWALL IN THIS AREA.

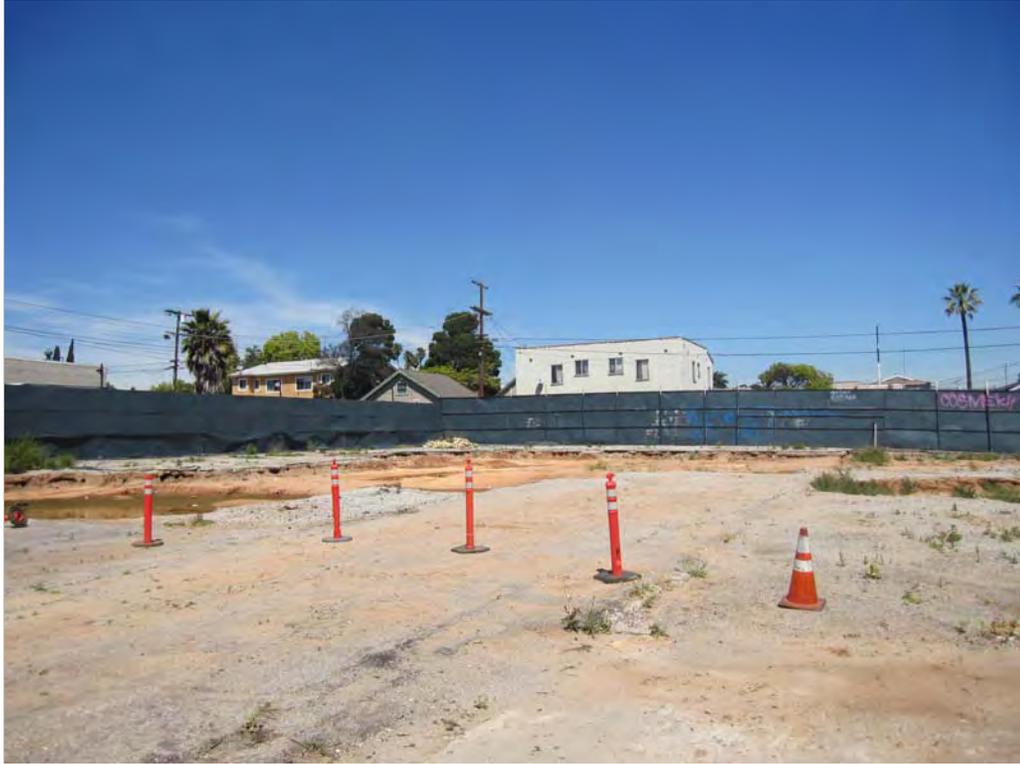
As previously indicated, the Property currently is an uneven dirt lot that has recently undergone remedial excavation. With the exception of the remediation areas, no additional obvious disturbed areas were noted.

Photo 1. View of the Property facing north.

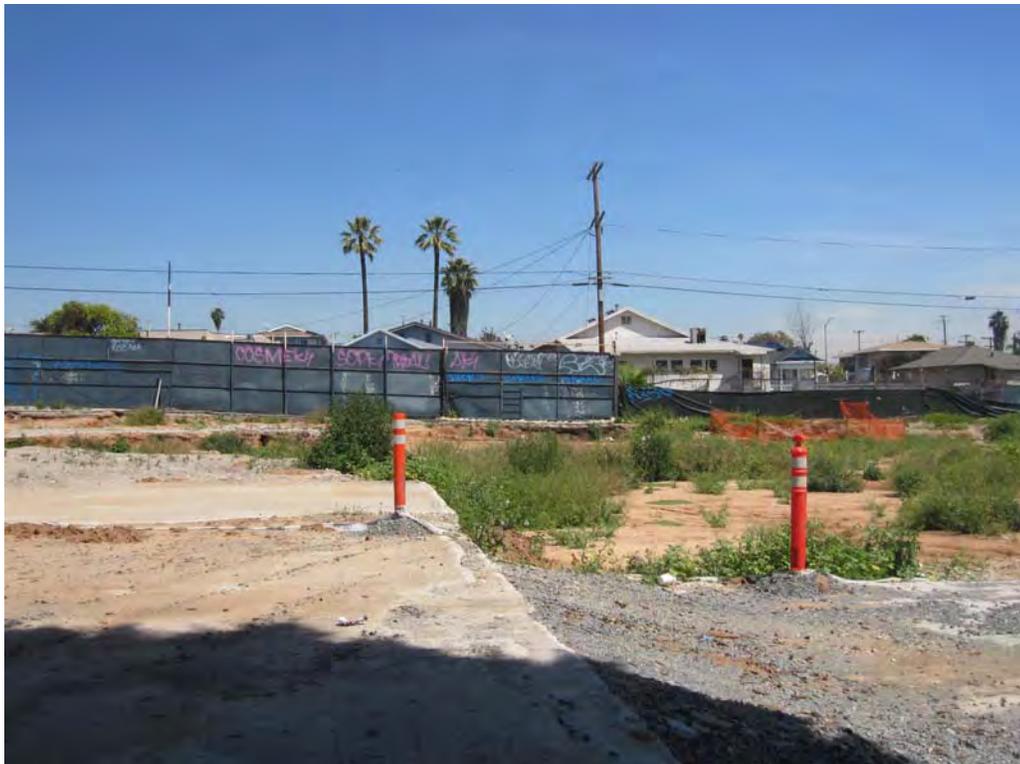
Photo 2. View of the Property facing northeasterly.

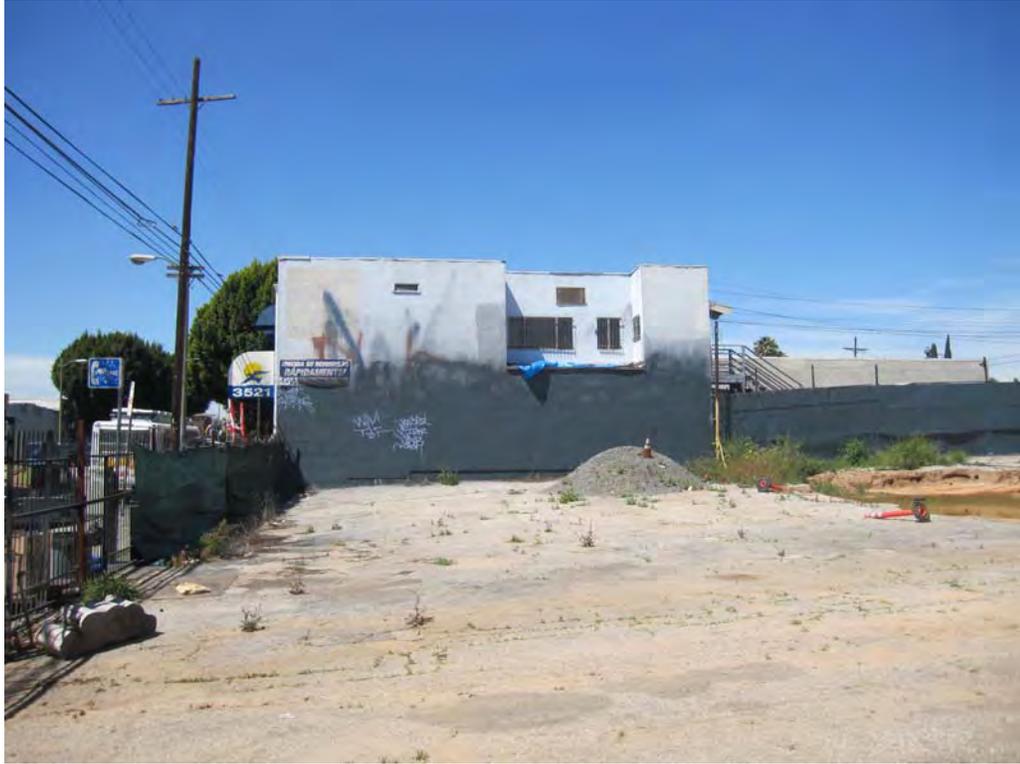
Photo 3. View of the Property facing northwesterly.

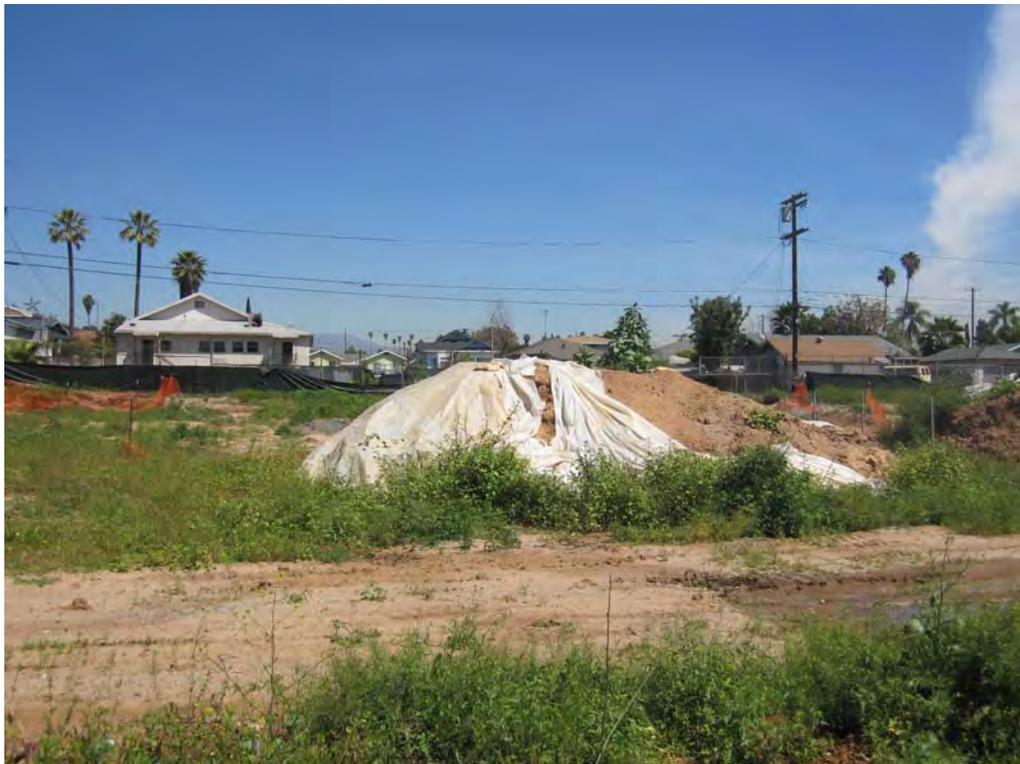
Photo 6. Northeasterly view of the adjacent site to the southeast

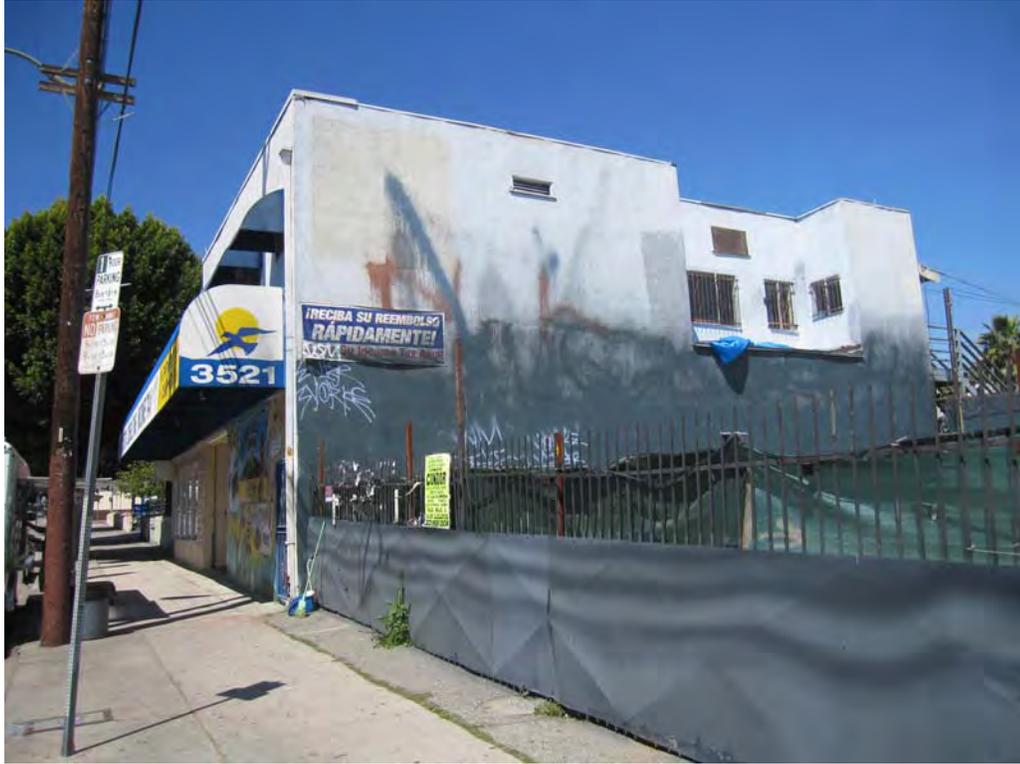
Photo 7. Cocktail lounge and Income tax office located adjacent to the northwest.

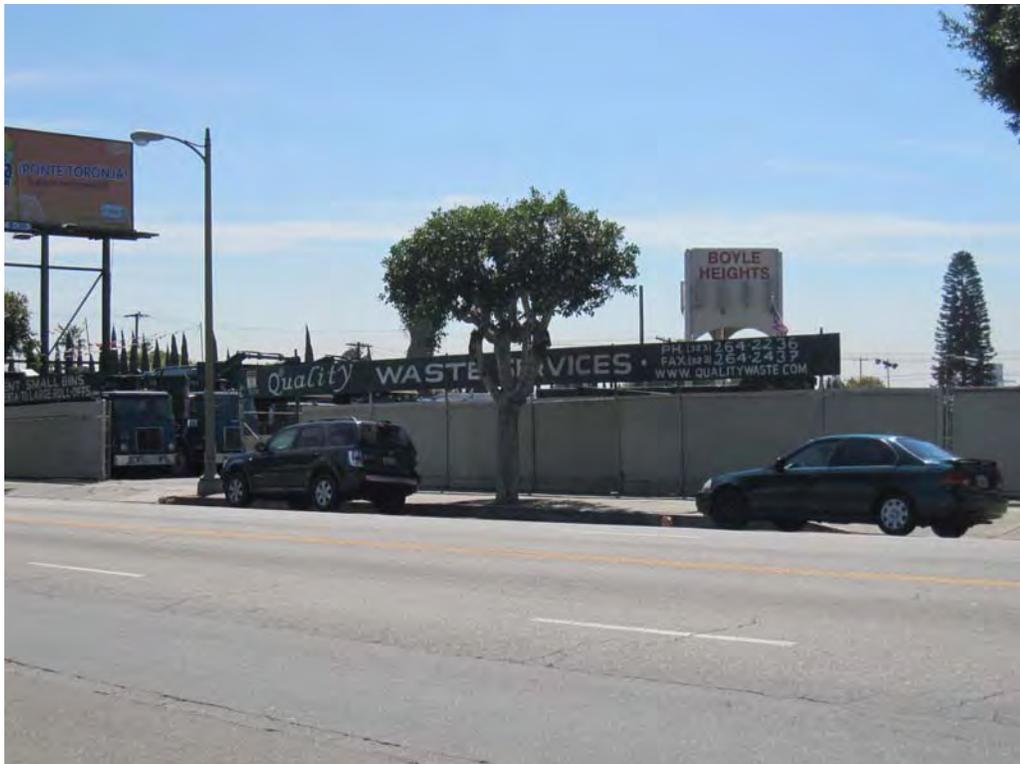
Photo 8. Quality Waste Services, across Whittier Boulevard, southwest of the Property
