March 5, 2004

Memorandum No.
2004-AT-1802

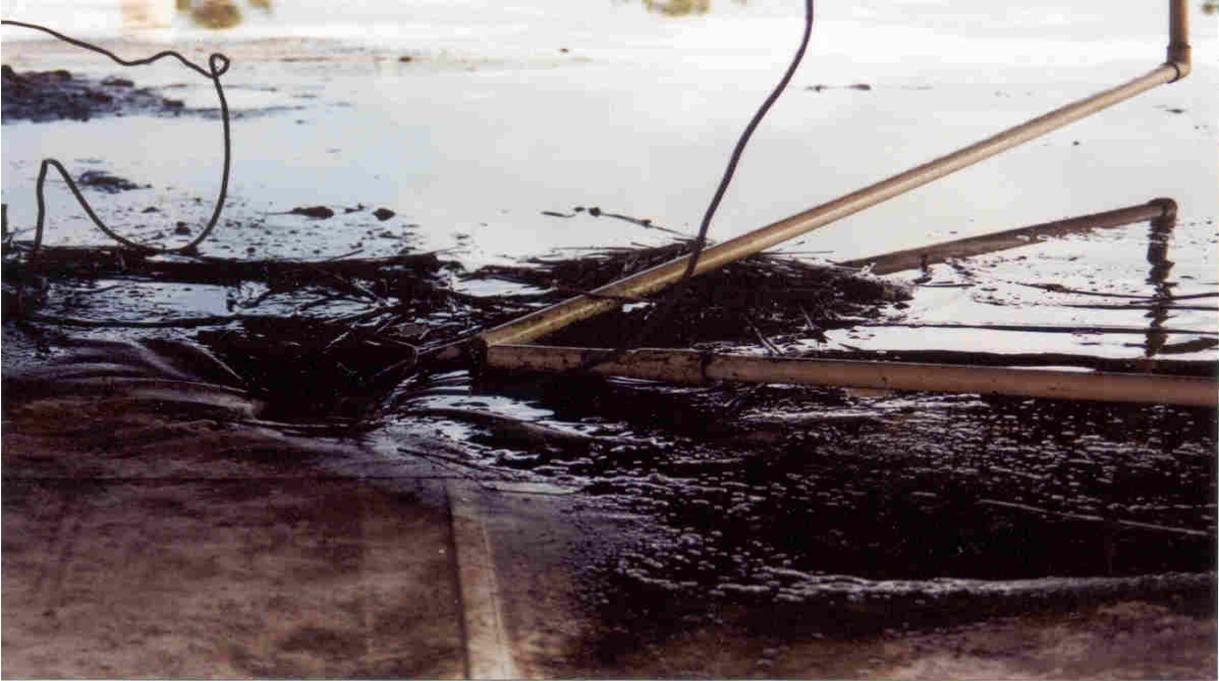
No.1, Building A Roof – Pooling water due to defects in AC condensation lines.

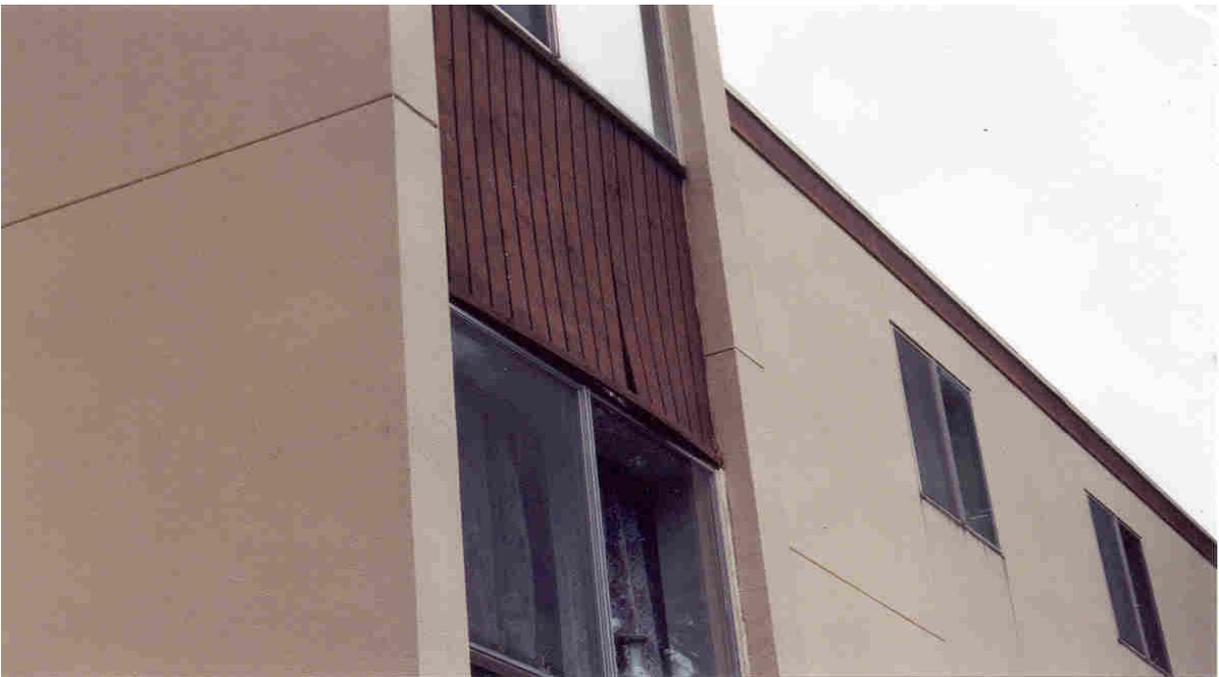
No. 2, Building A – Exterior siding panel is rotted.
This condition was noted in several places.

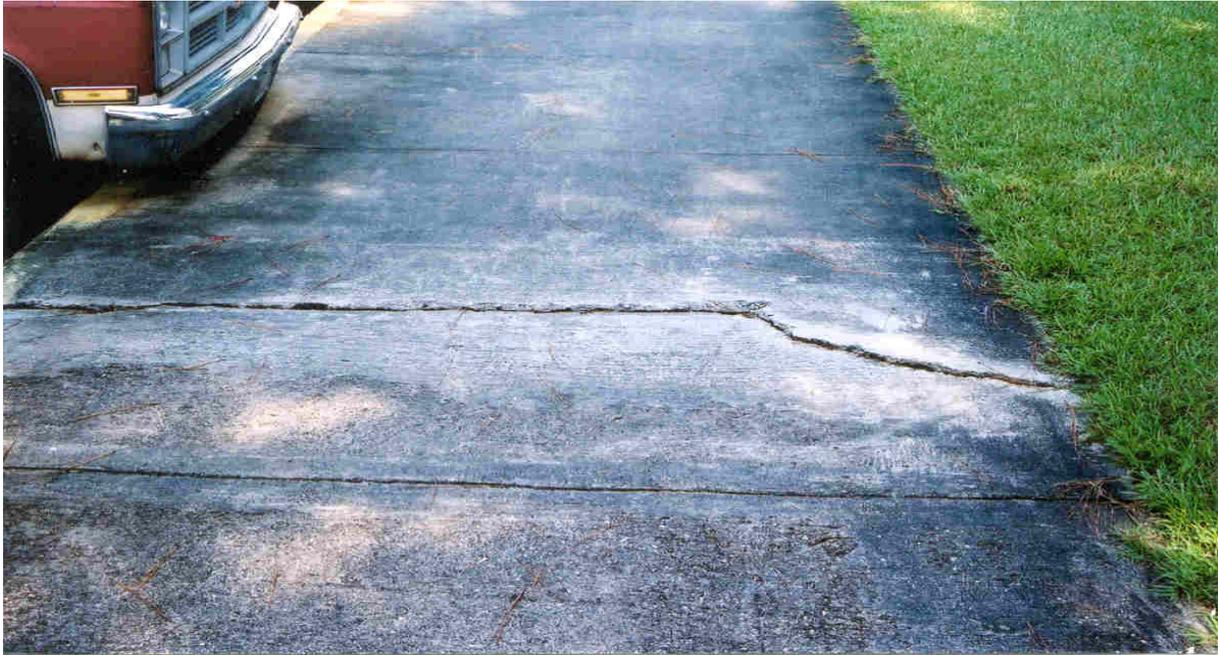
No. 3, Building A – Crack and upheaval in walkway is a tripping hazard.

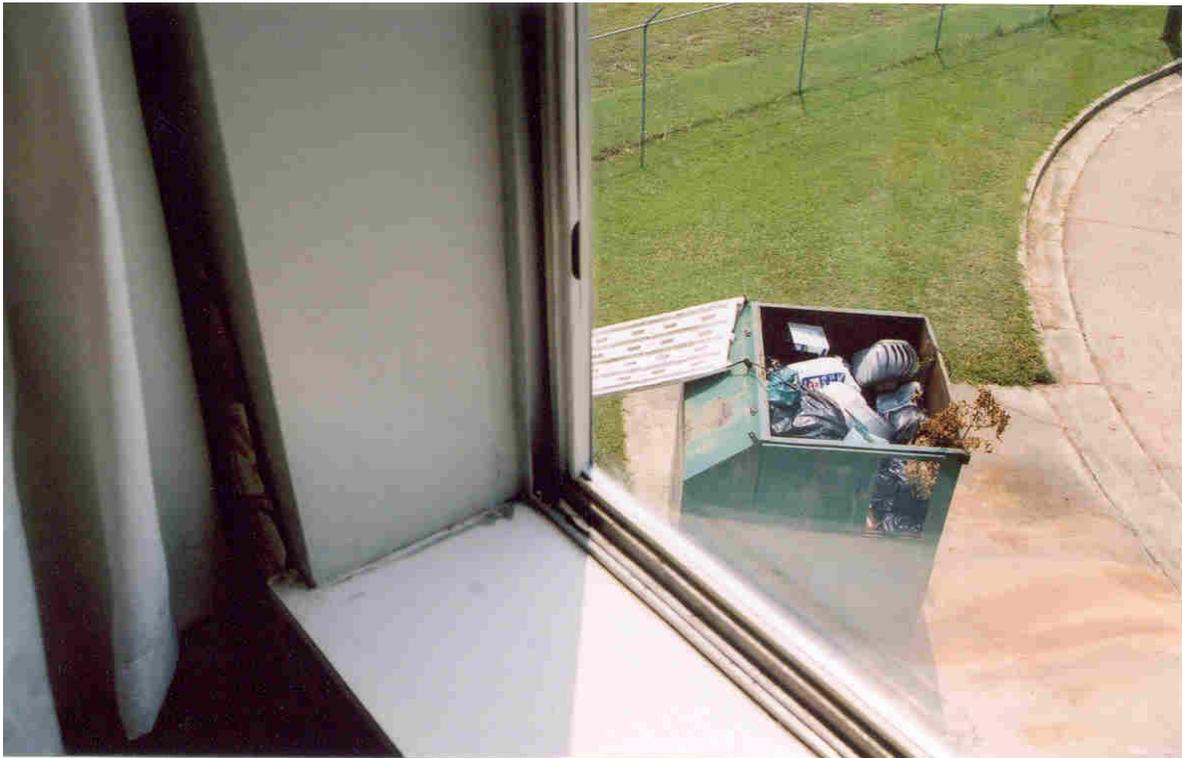
No. 4, Building B – Trash dumpster with missing and damaged covers.

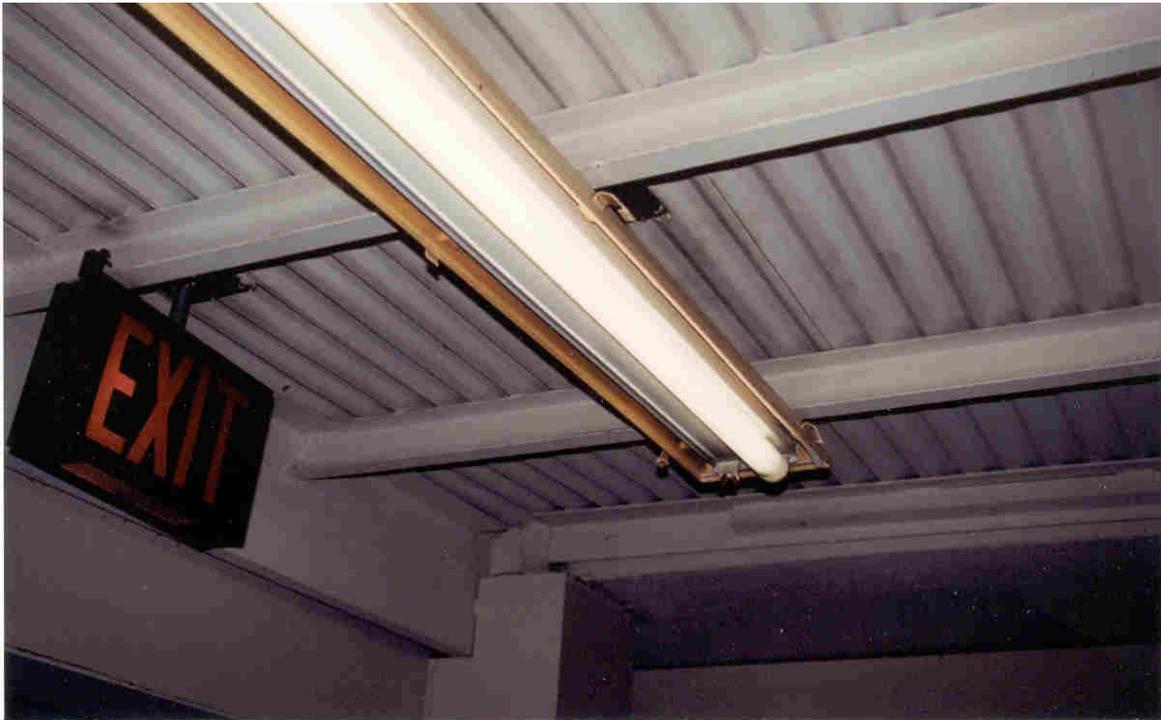
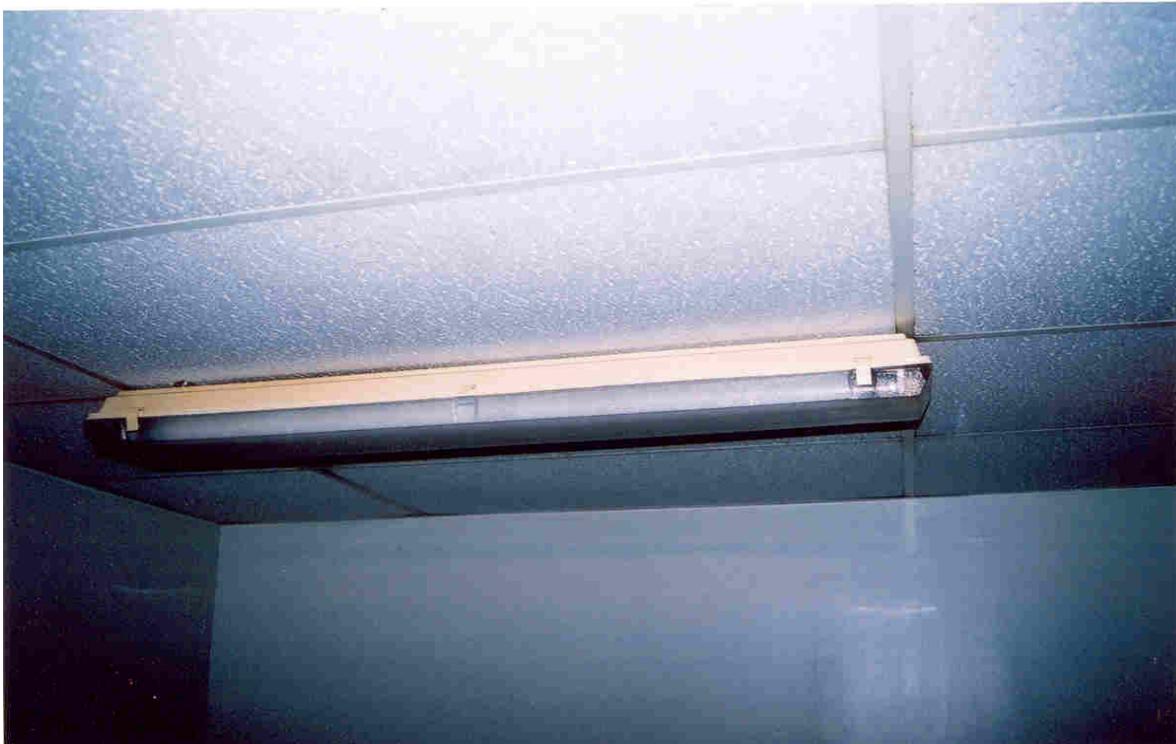
No. 5 & 6, Buildings A and B, stairwells – Burned out or missing bulbs and missing lens covers.

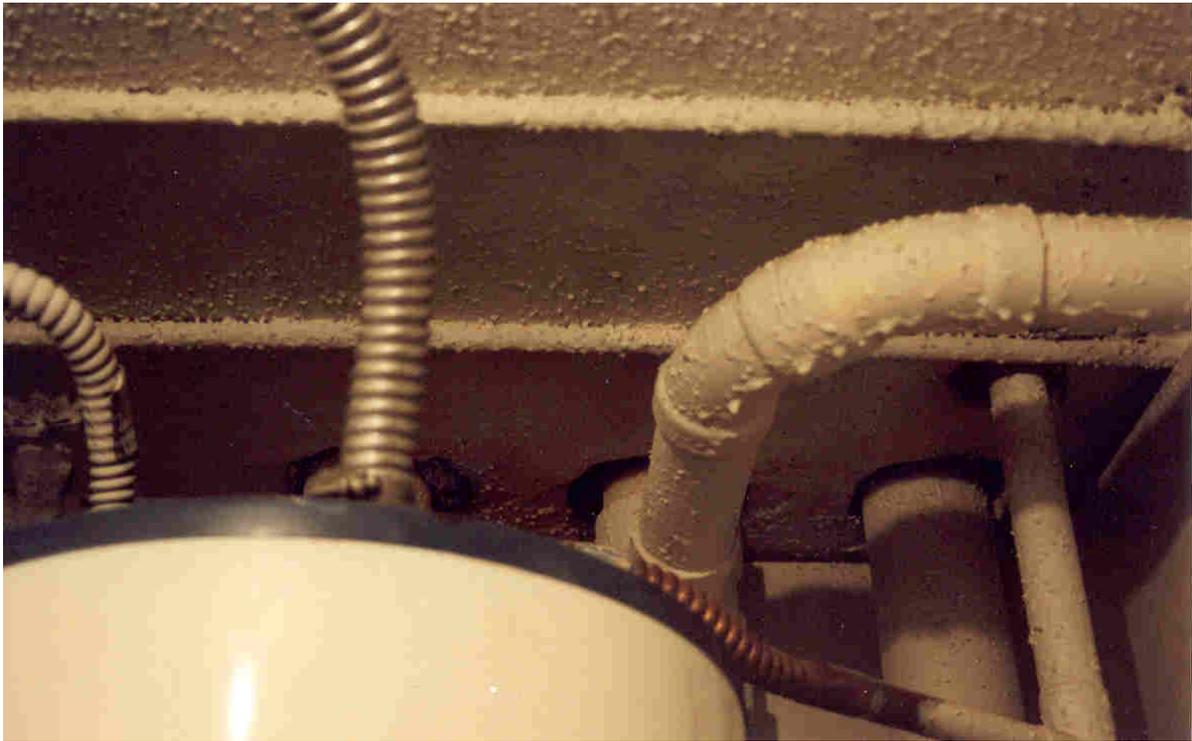
No. 7, Unit 101A – Water heater closet – plumbing holes in ceiling not sealed to provide fire barrier.

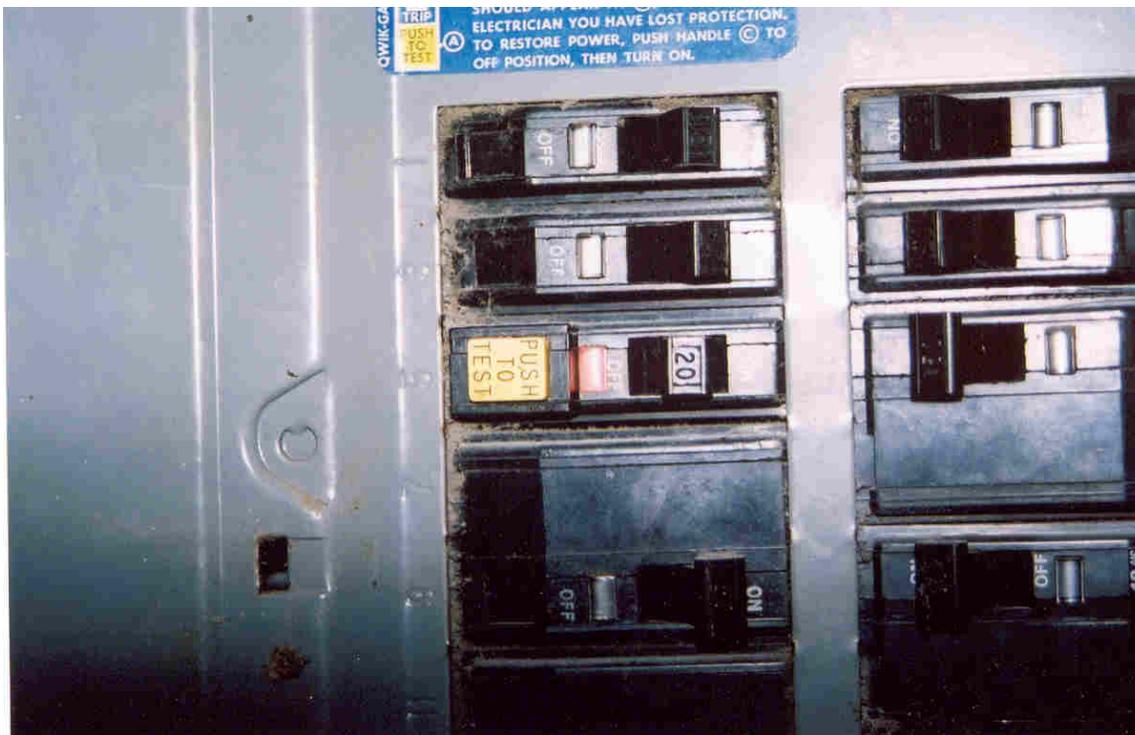
No. 12, Unit 318B – GFI breaker for bathroom was defective.

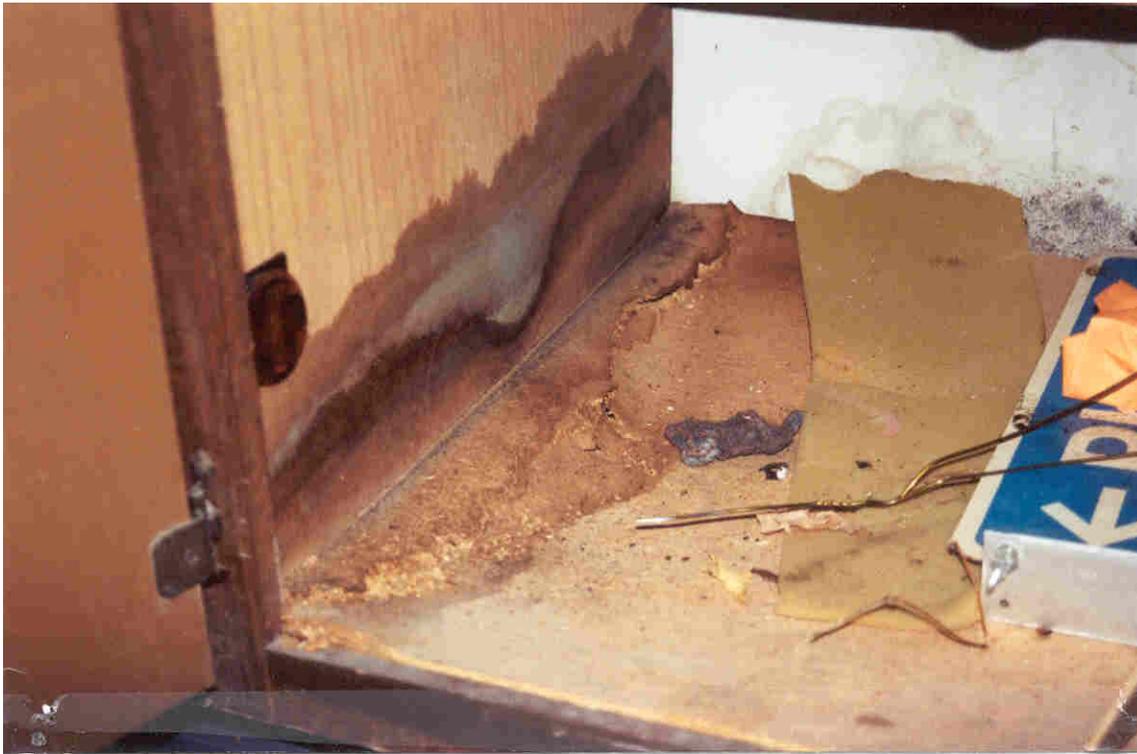
No. 13, Building A Common room – sink cabinet sides and bottom shelf are rotted out.

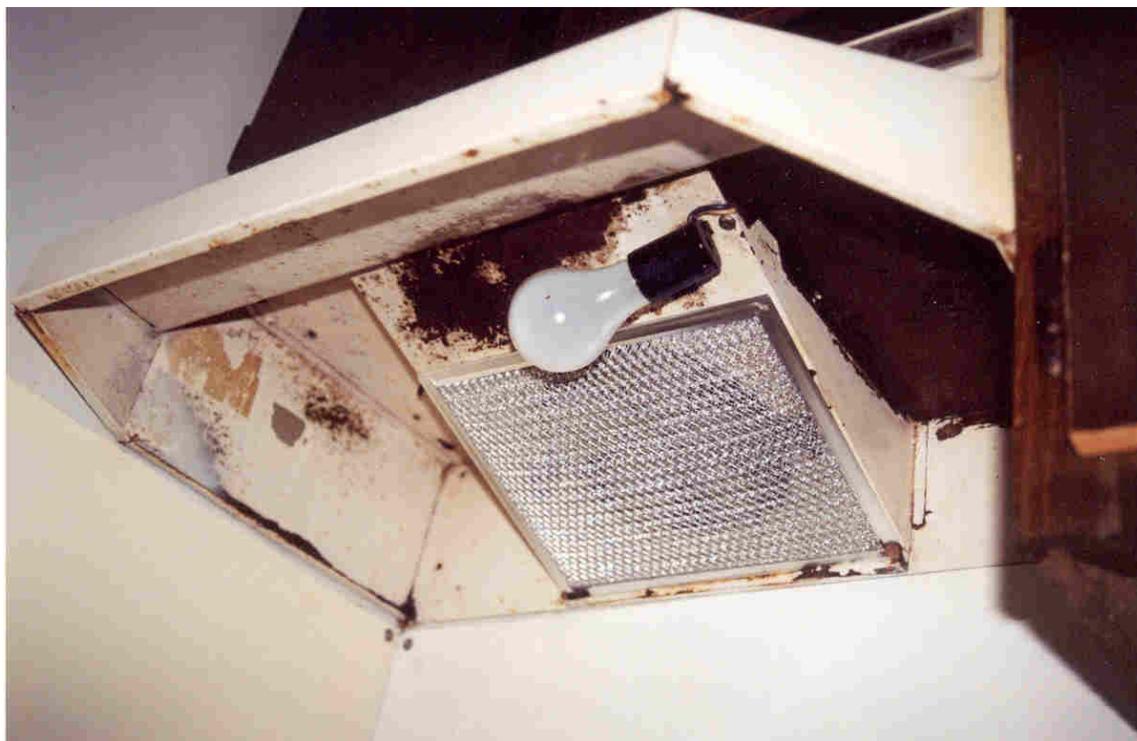
No. 16, Unit 309A – Stove vent hood is rusted, bulb cover is missing, and wiring exposed. This condition was similar in most apartment units.

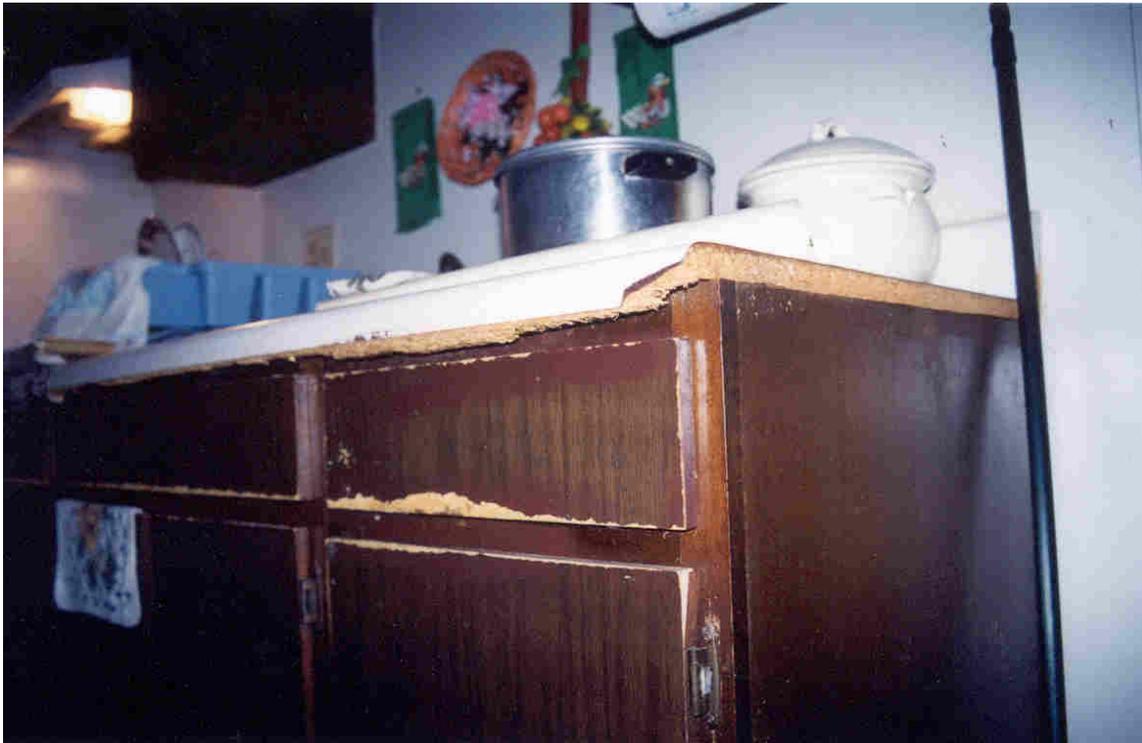
No. 17, Unit 214A – Kitchen sink cabinet is delaminating. Countertop underlay is crumbling. Similar conditions were noted in nearly all units inspected.

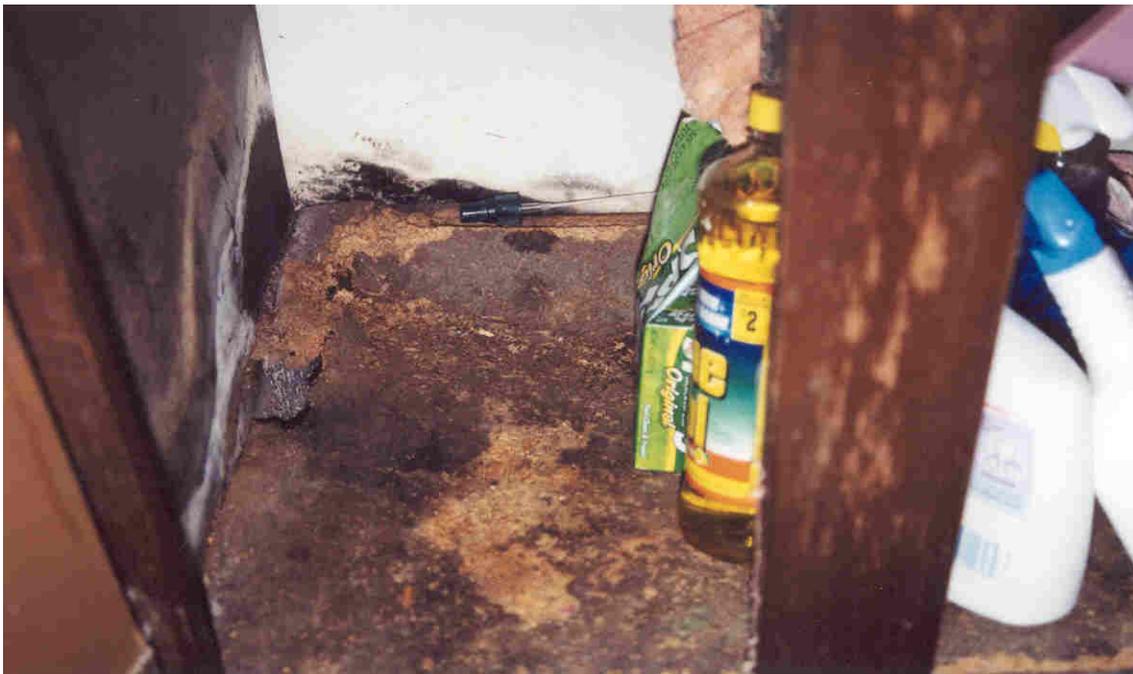
No. 18, Unit 314A – Kitchen sink cabinet, sidewall and bottom shelf are rotted out and mildewed.

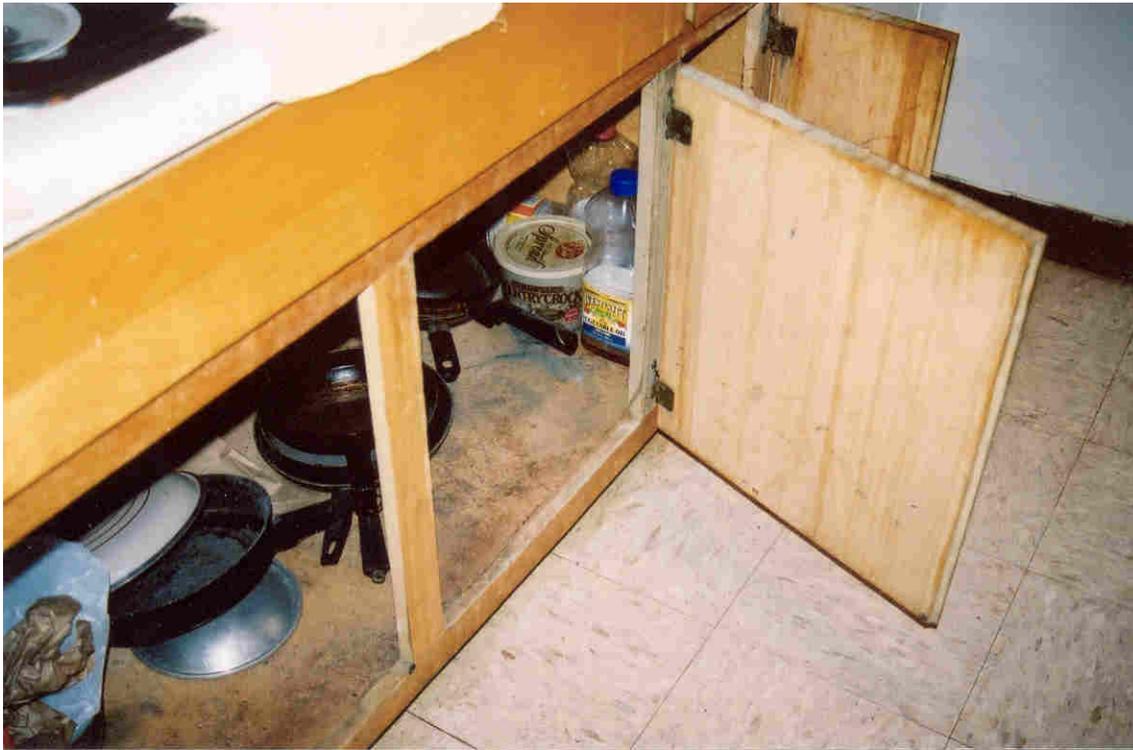
No. 21, Unit 103B – Kitchen cabinets were replaced, but staining was incomplete and shelving was omitted.

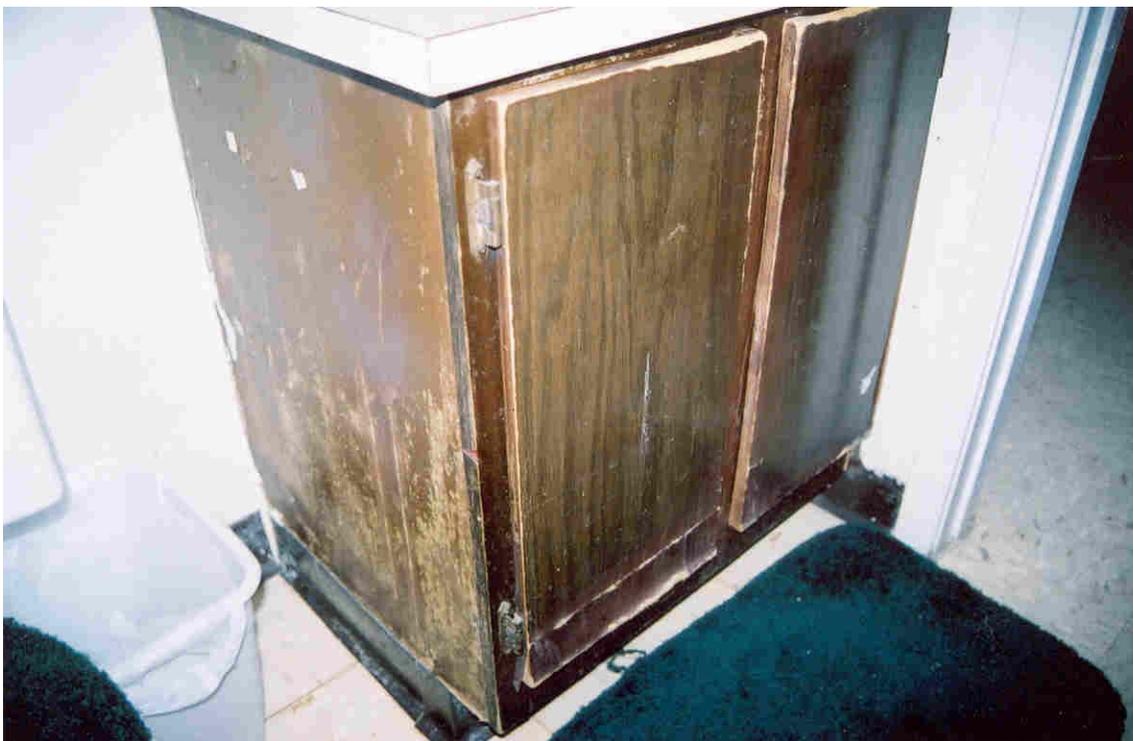
No. 22, Unit 203B – Bathroom vanity is delaminating. Side finish and inside shelf surface are deteriorated and not impervious to moisture.

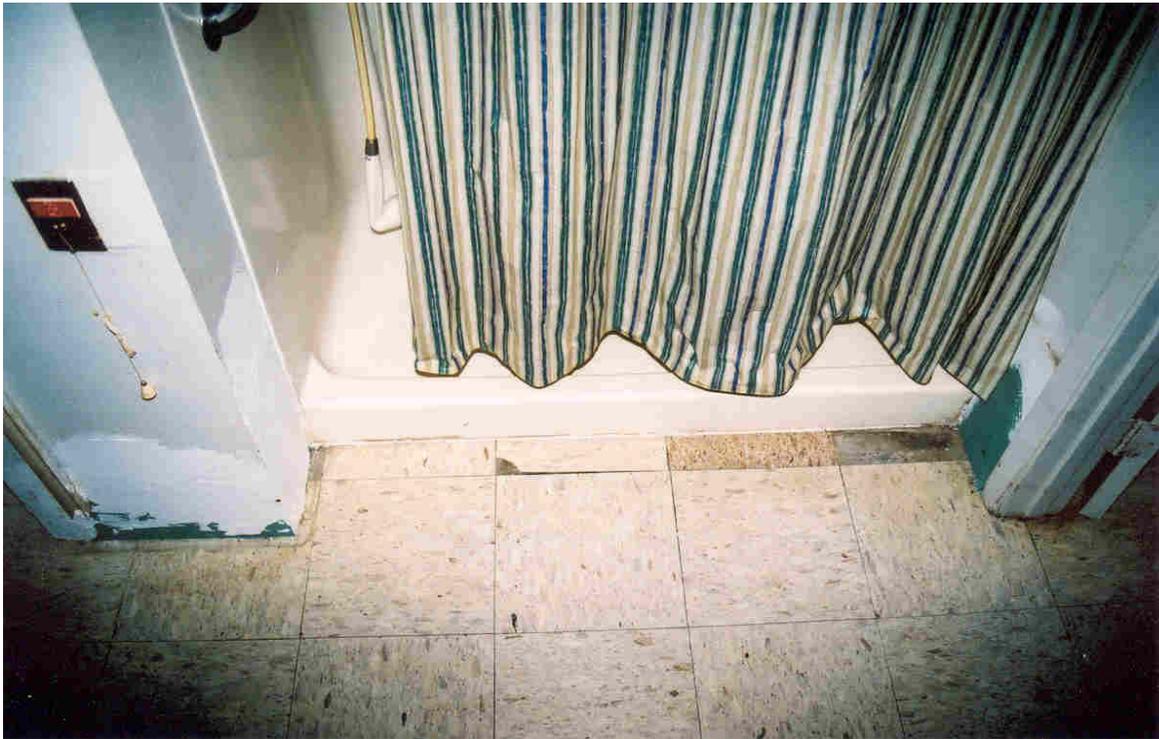
No. 23, Unit 101B – Bathroom floor has damaged and missing tiles. Wall repairs were not painted. Vinyl baseboard is missing.

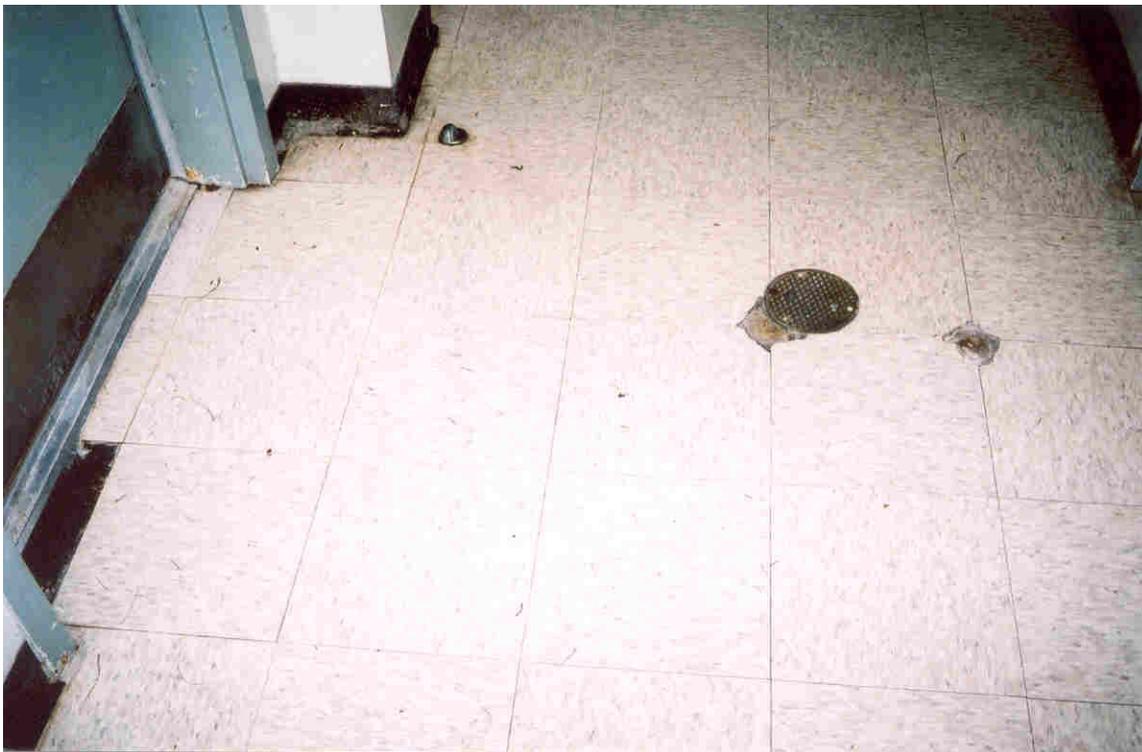
No. 24, Building B, east stairwell – missing and damaged floor tiles.

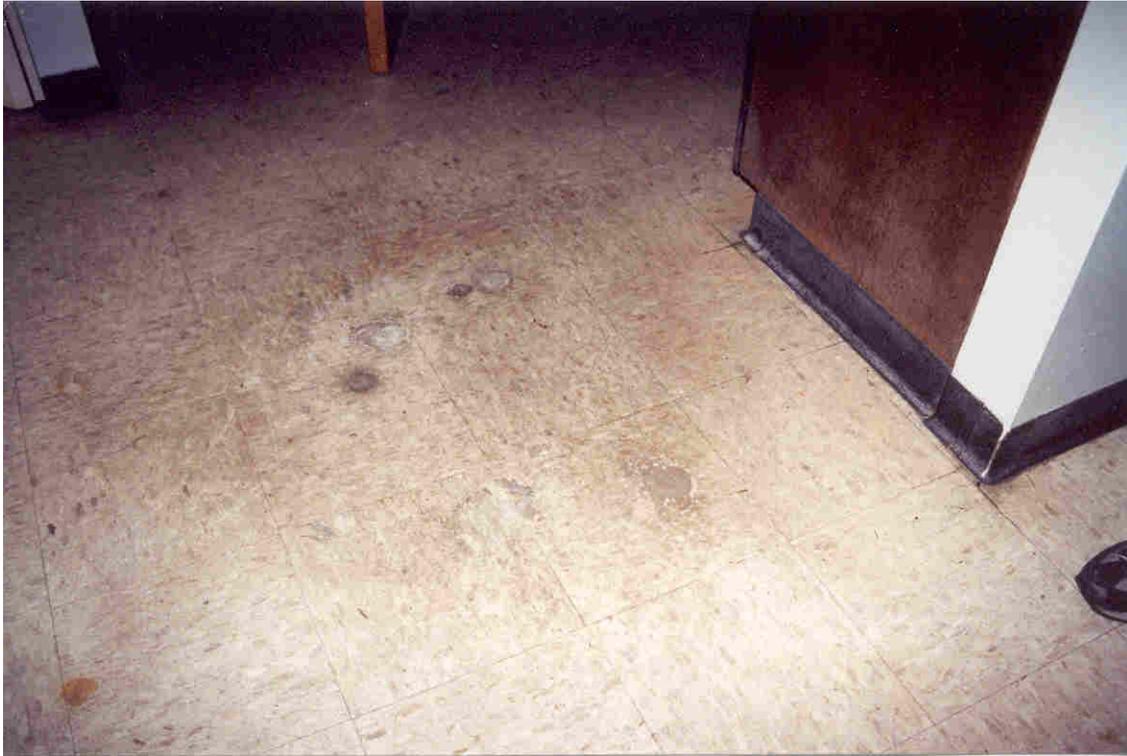
No. 25, Unit 308A – Dining area floor tiles are completely worn through.

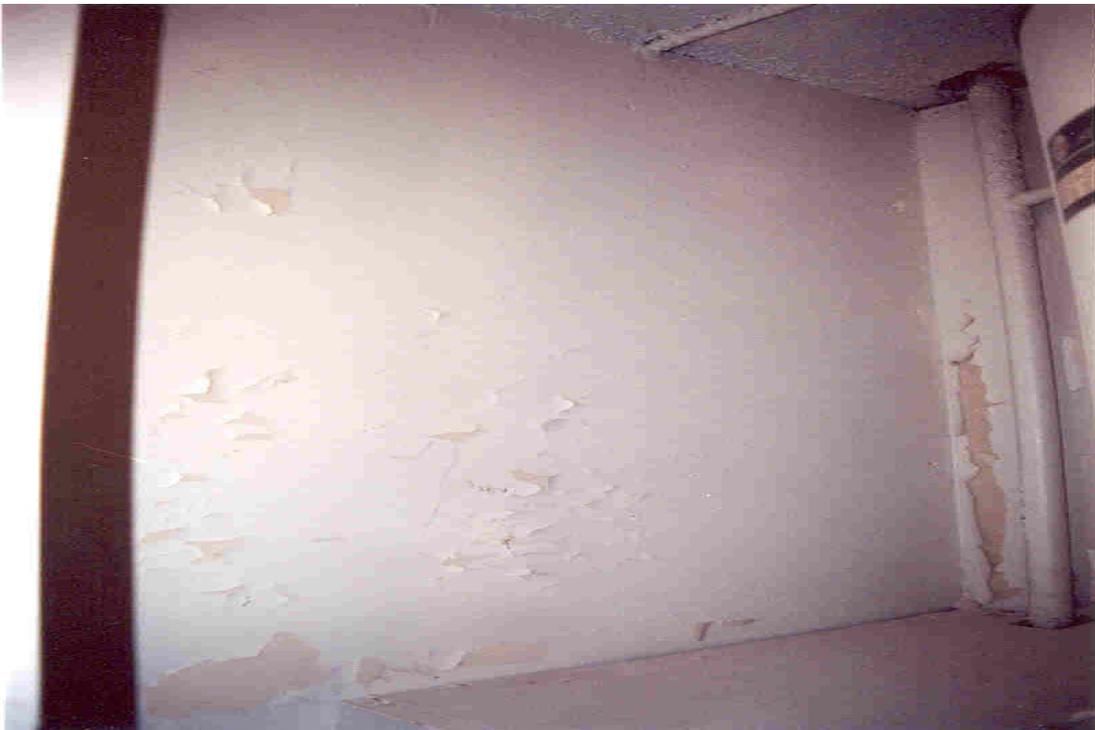
No. 26, Unit 301A – Peeling paint in utility closet. Tenant stated the apartment had not been painted in 16 years.

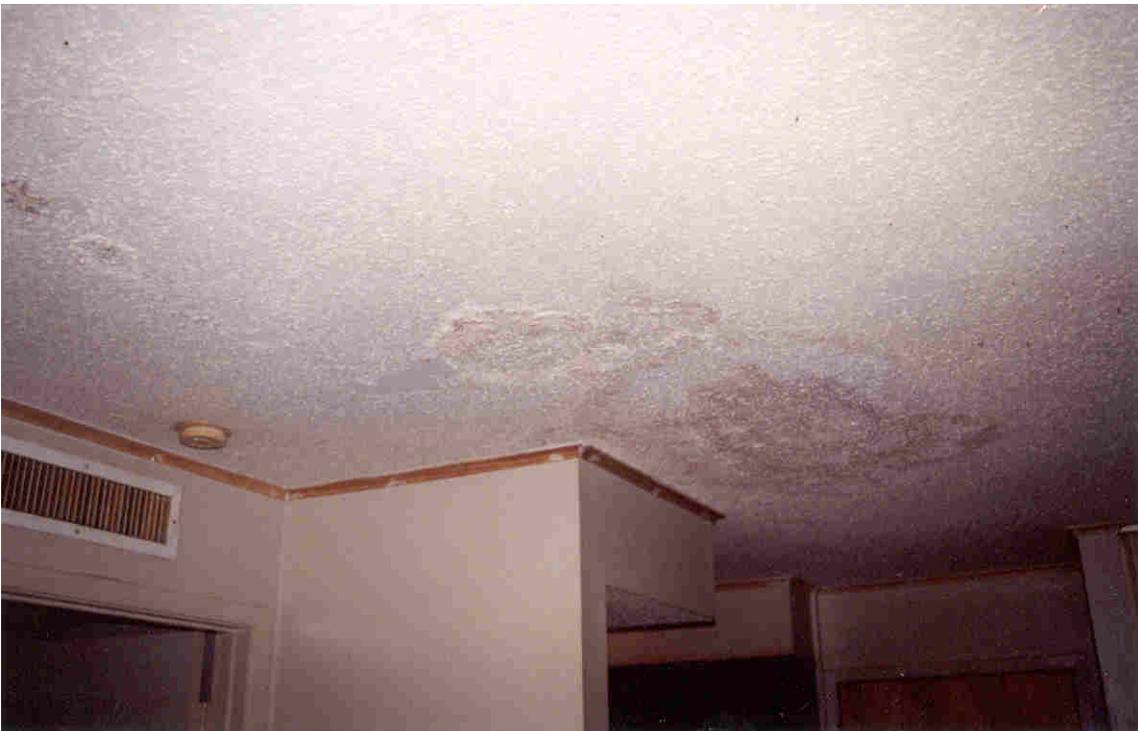
No. 28, Unit 303A – Water damage to living room ceiling has not been repaired. Trim molding was not painted.

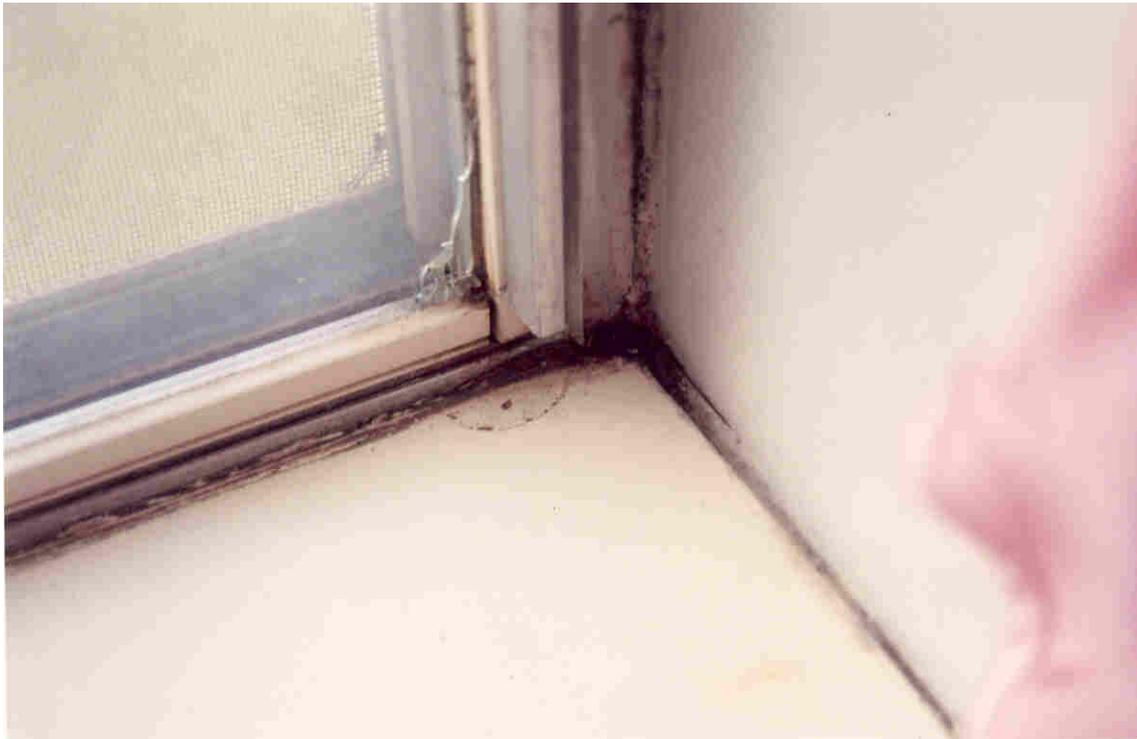
No. 29, Unit 214 A – Living room window shows deterioration and mildew due to moisture damage. The glass panes were not adequately sealed.

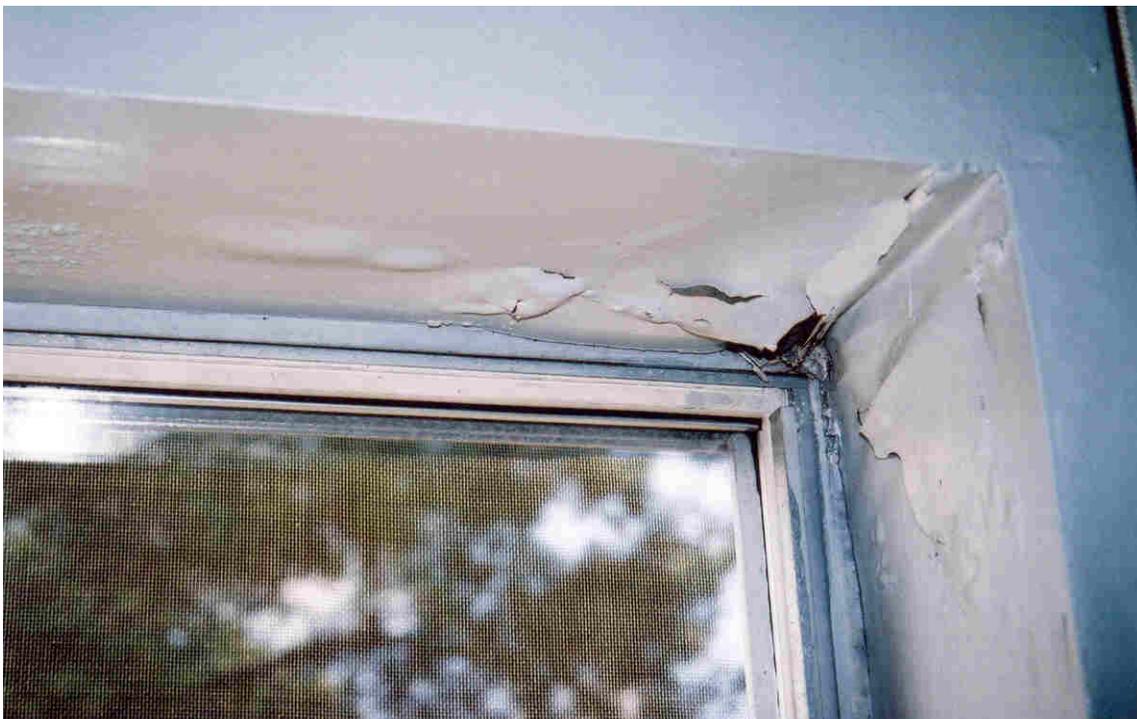
No. 30, Unit 203B – Moisture damaged drywall at window frame. The age and condition of window units makes them too difficult to operate, and subject to moisture intrusion.
