Kenilworth Courts Public Housing & Property of Kenilworth Parkside Resident Management Corporation

Attachment 9 Rehabilitation Cost from PNA

Attachment 10 Structural Deficiencies Documentation

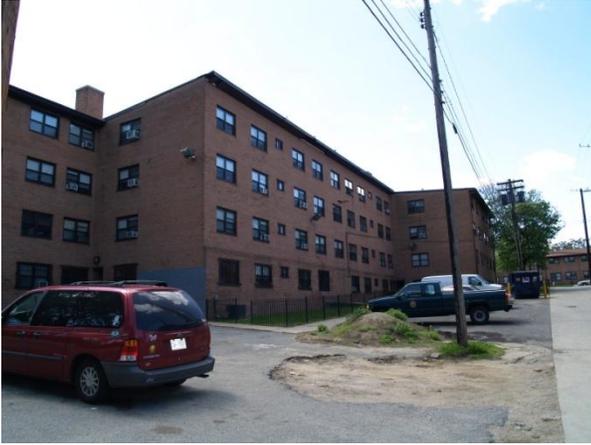
Typical Building Exterior with roofing problems, inefficient windows and broken pavement.

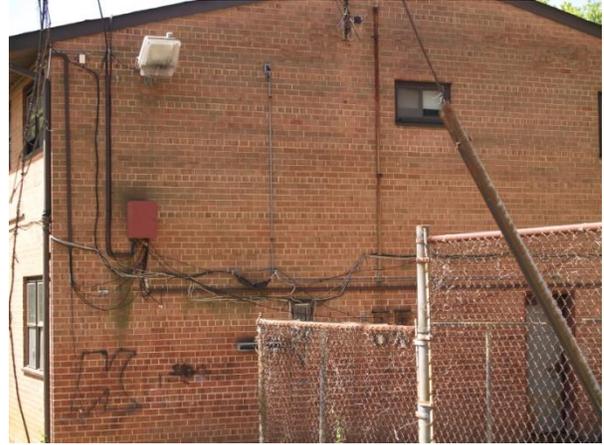
Exterior of building with loose electric power wires creating very hazardous conditions.

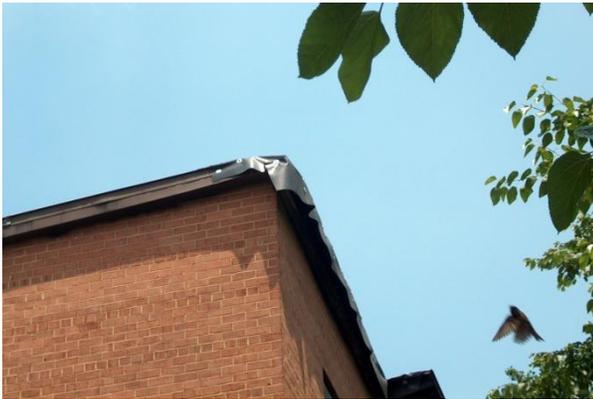
Poor Condition of Fascia Boards, soffits & flashing

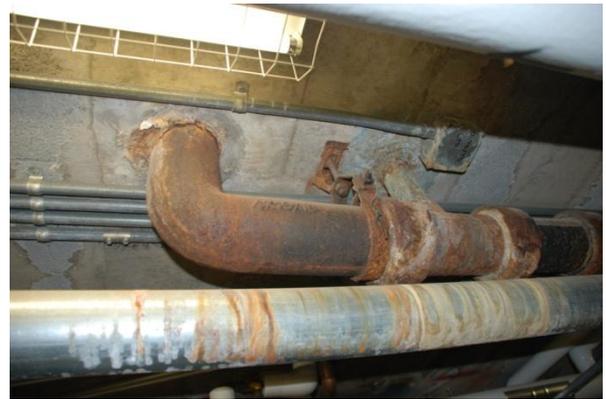
Old and rusted sewer pipes

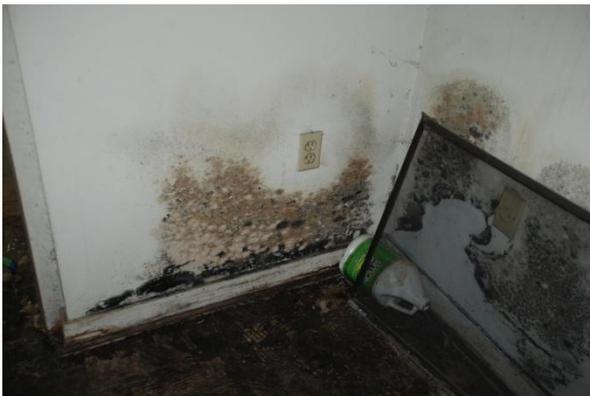
Water damaged unit with mold on walls and floors

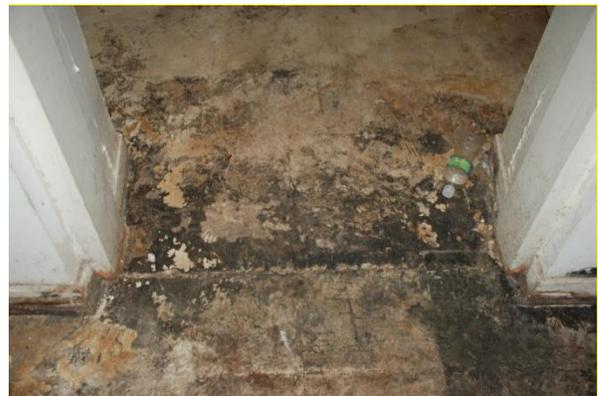
Very poor condition of flooring

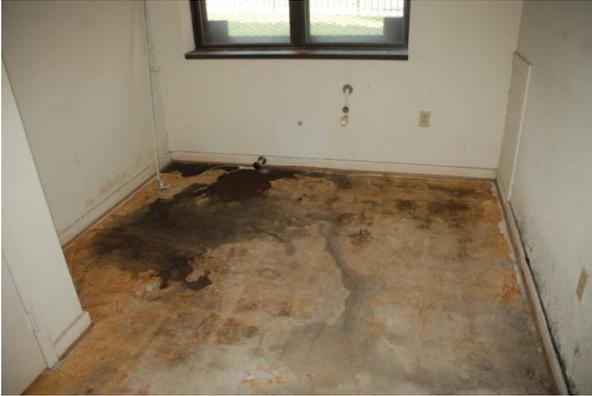
Poor condition of wood floors in unit

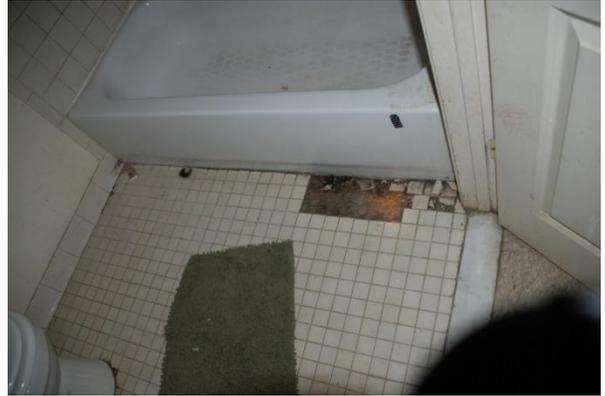
Poor condition of tiles and underlayment in bathrooms

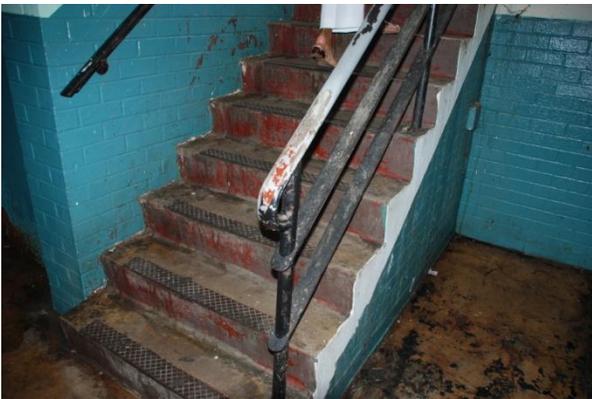
Poor condition of stairs with non-compliant railings.

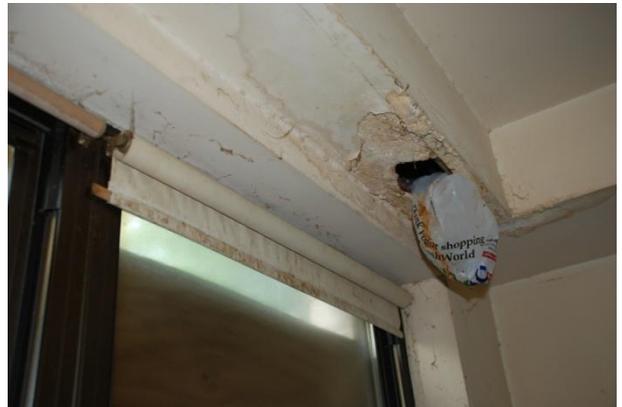
Inefficient windows with severe leakage problems

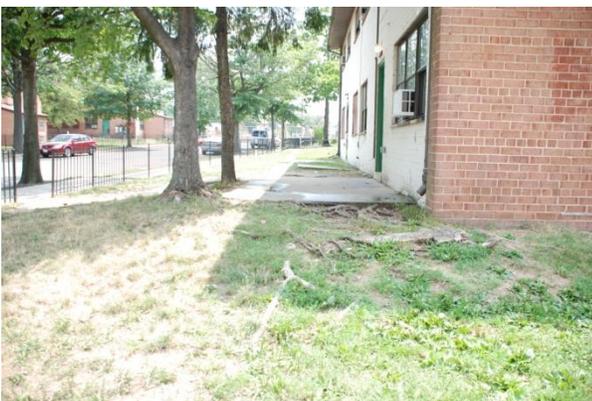
Typical condition of broken patios, erosion problems ,  
negative grading and poor landscaping

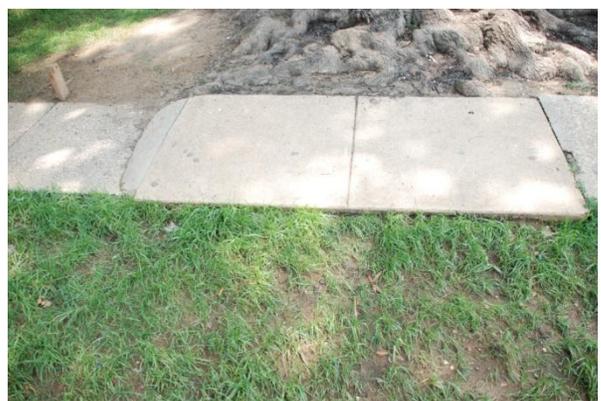
Broken and uneven sidewalks

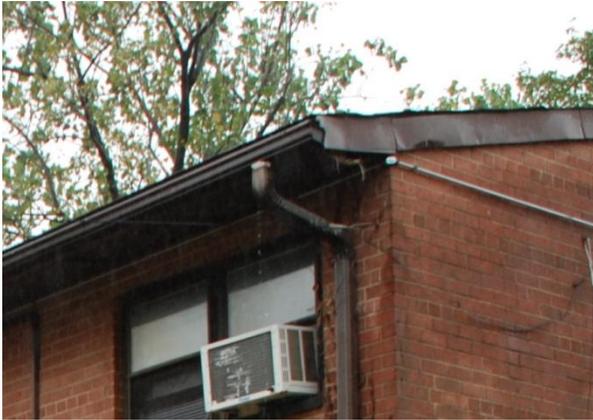
Roofing in need of replacement. Damaged fascia boards /flashing and downspouts. Inefficient windows. Use of window air conditioners. Wet walls.

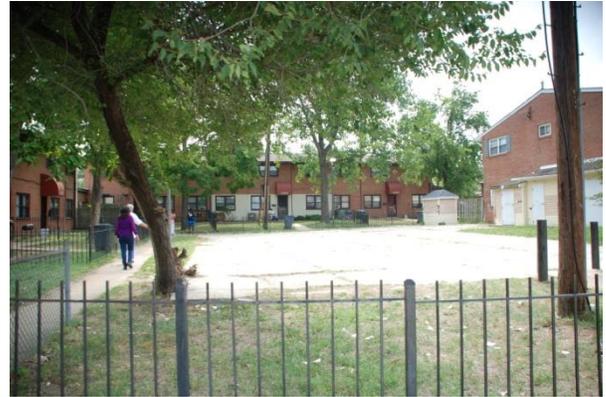
Large and inefficient use of open spaces. Poor landscaping elements.

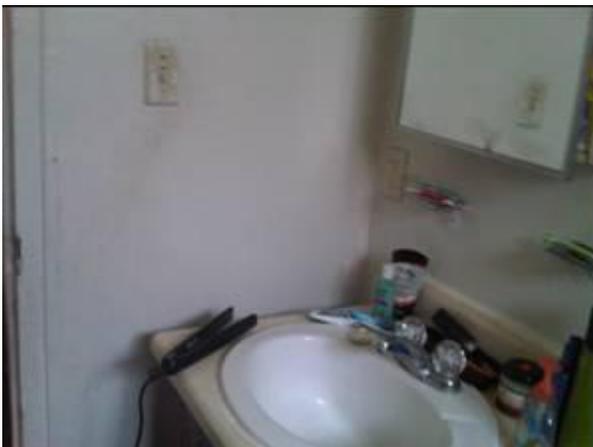
No GFI's in bathrooms. Very poor condition of bathroom accessories and fixtures.

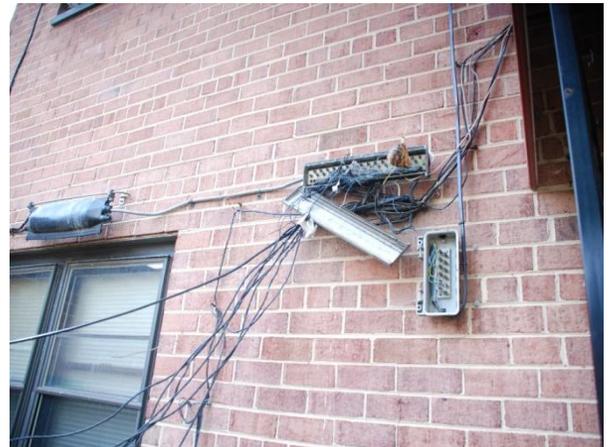
Loose Cables at exterior of buildings creating hazardous conditions

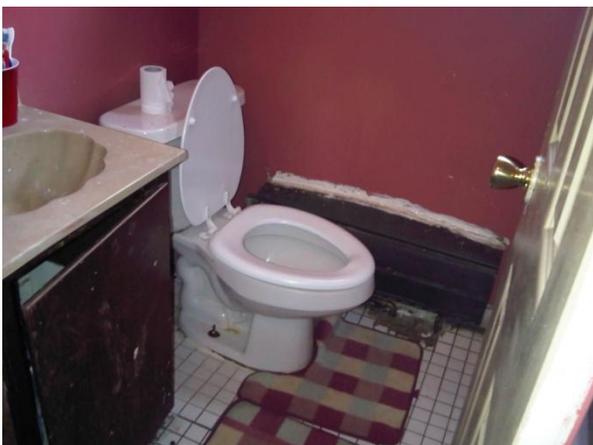
Vanities, plumbing fixtures and CT flooring in need of replacement. Damaged underlayment due to water seepage.

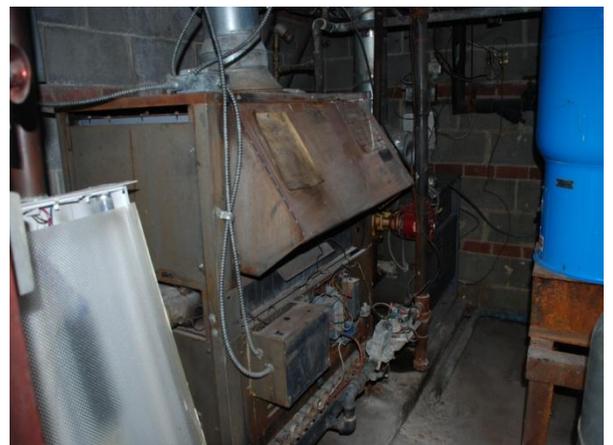
Poor condition of central boiler.

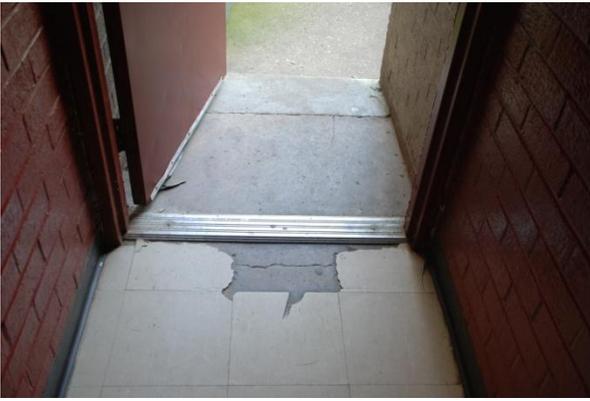
Poor Condition of Finishes at Common areas

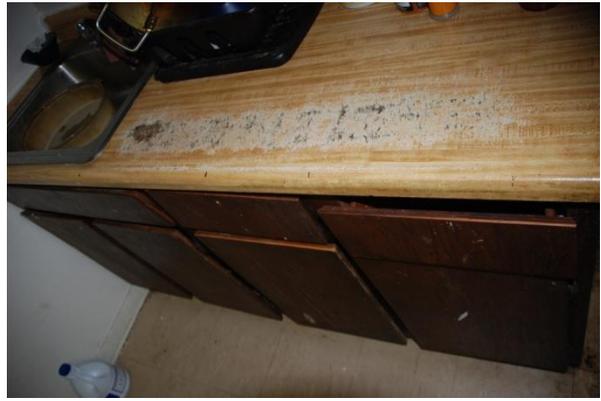
Kitchen Cabinets/Countertops , VCT Flooring at end of their useful life.

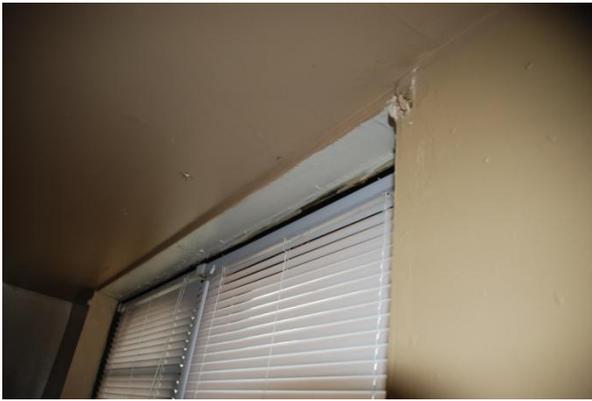
Poor condition of windows. Water damaged heads and sills of windows due to water leakage.

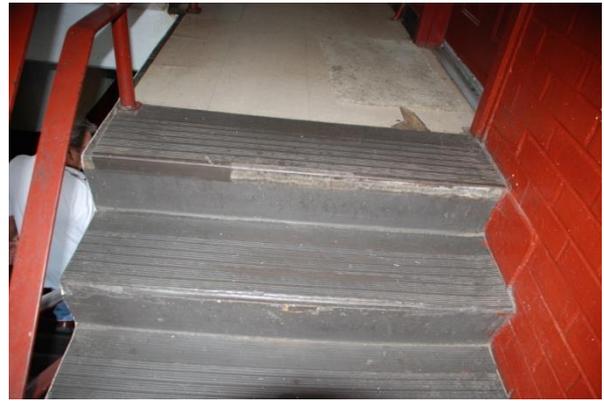
Safety issues due to non-compliant railings and damaged steps at common stairs

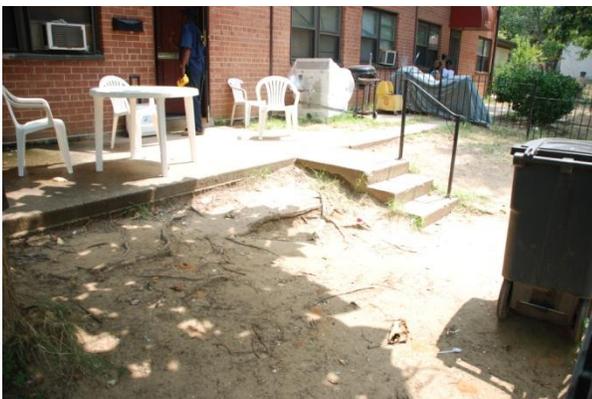
Severe Grading and Storm Drainage Problems

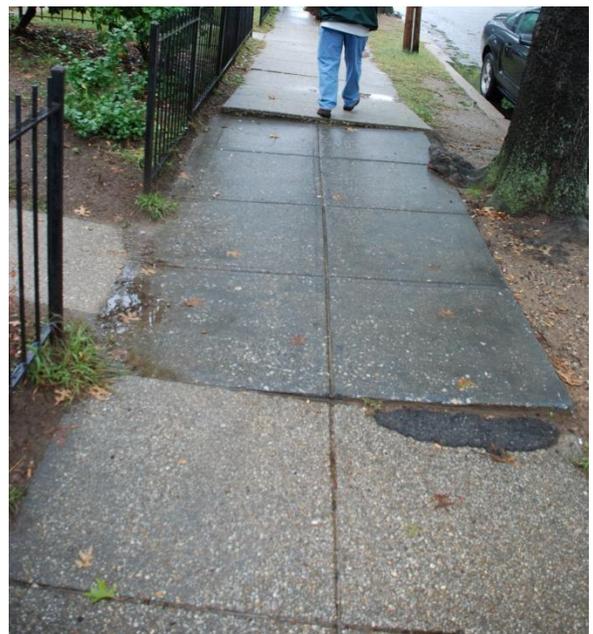
Cracked and settled sidewalks throughout the site
